## **MIAMI-DADE COUNTY PERFORMANCE TEST REPORT**

# **Report No.**: B1028.01-401-18

# PRODUCT TYPE: Aluminum Storefront SERIES/MODEL: FL500

Test Dates:	06/30/11
Through:	07/08/11
Report Date:	01/03/12
<b>Test Record Retention End Date</b> :	07/08/21
Miami-Dade County Notification No.:	ATIFL 11003

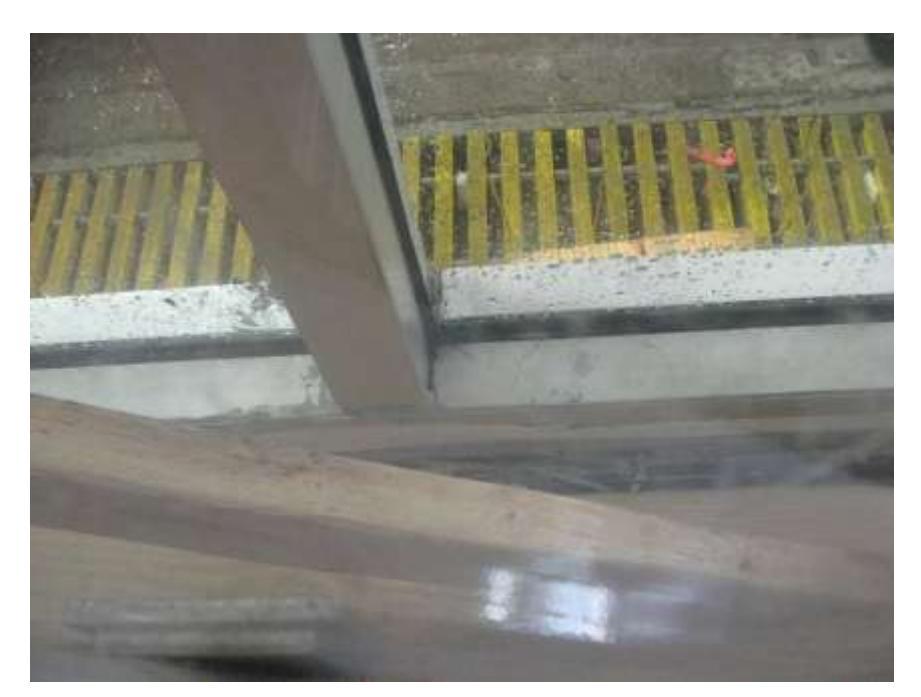
Photo No. 4 Specimens #2 and #3 Water accumulating in corners near glazing pocket during 15.04 psf water test

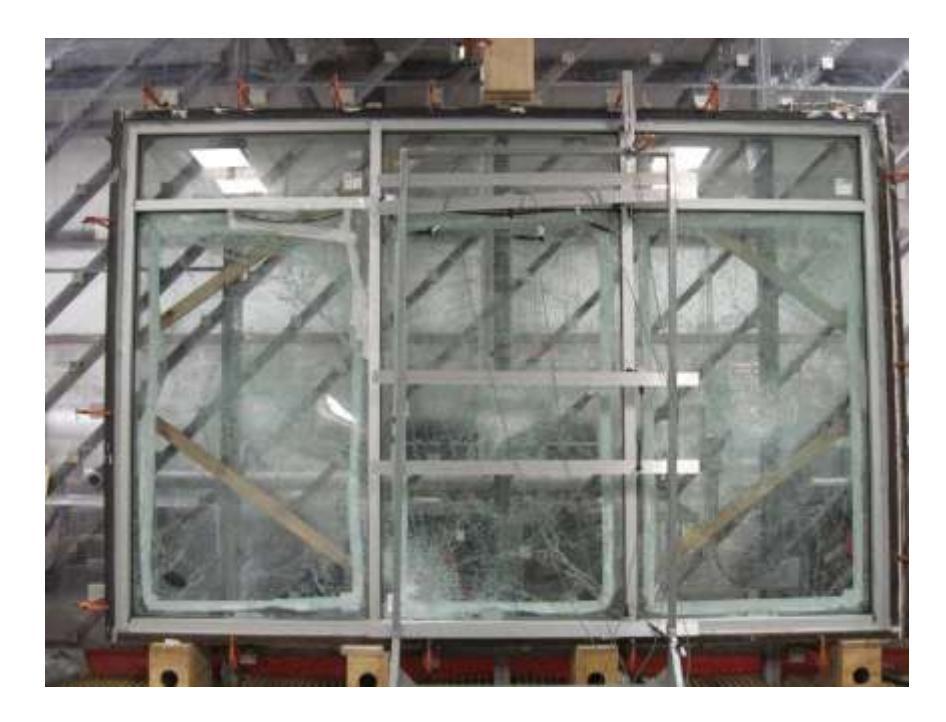
**Observations**: With 57 cycles remaining in the positive 30% to 100% range, specimen #1 the upper right corner of the glass pulled out of the glazing pocket. Specimen#1 was boarded up and testing continued through the rest of the cycling program with Specimens #2 and #3. No additional damage or deglazing was observed.

Photo No. 5 Specimens #1, #2, #3 Exterior view during TAS 203 cyclic loading; Specimen #1 at far left experienced a failure

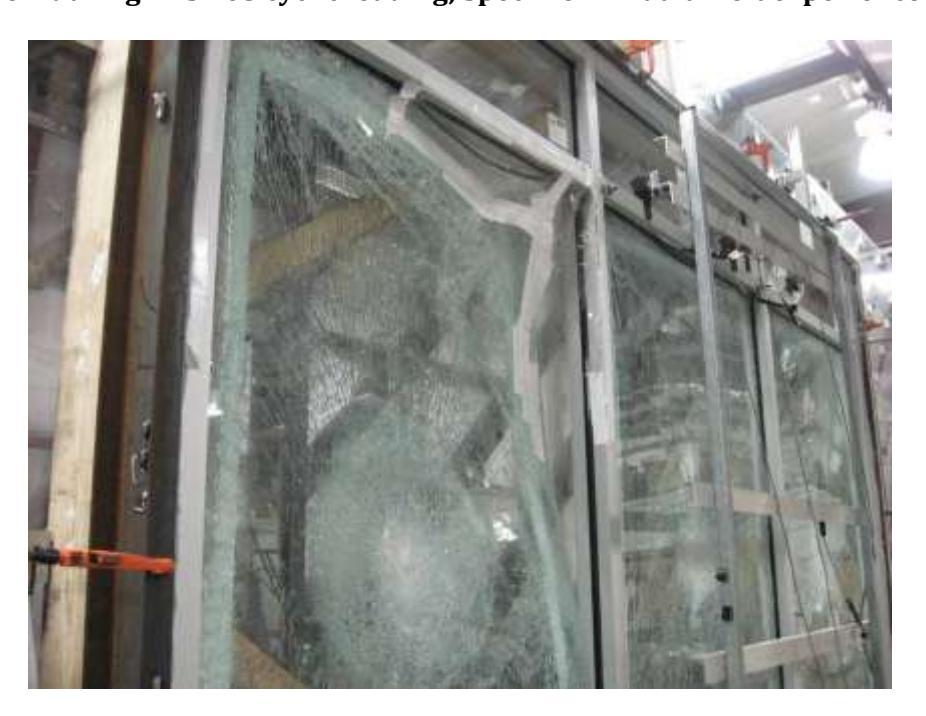
Photo No. 6 Specimen #1 Failure of glazing at upper right corner of specimen during TAS 203 positive loading

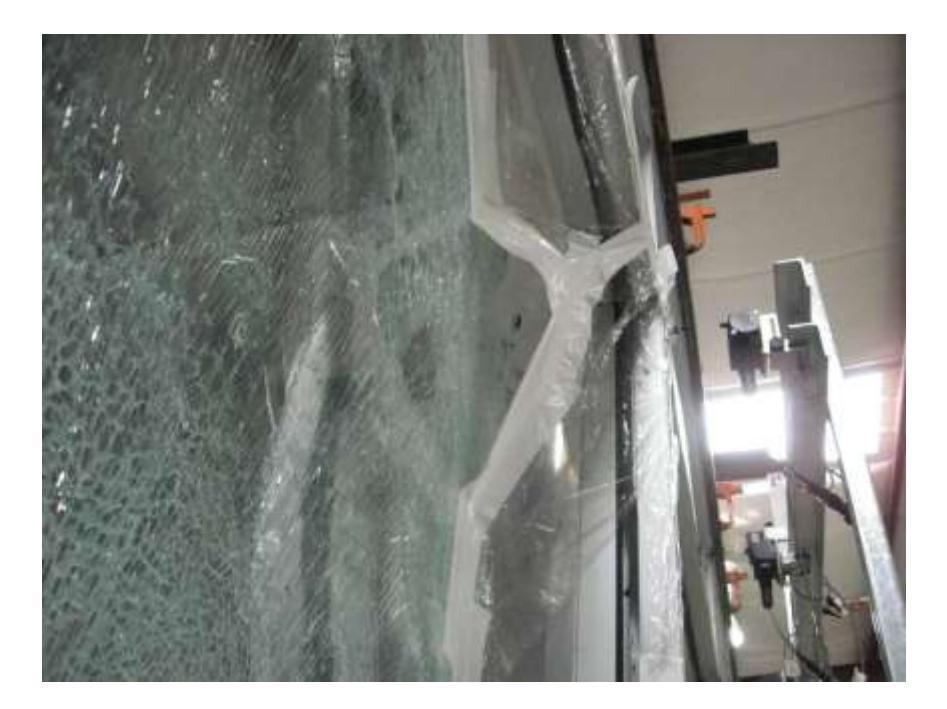
Photo No. 7 Specimen #1 Close-up of corner failure; glazing was pulled from glazing pocket

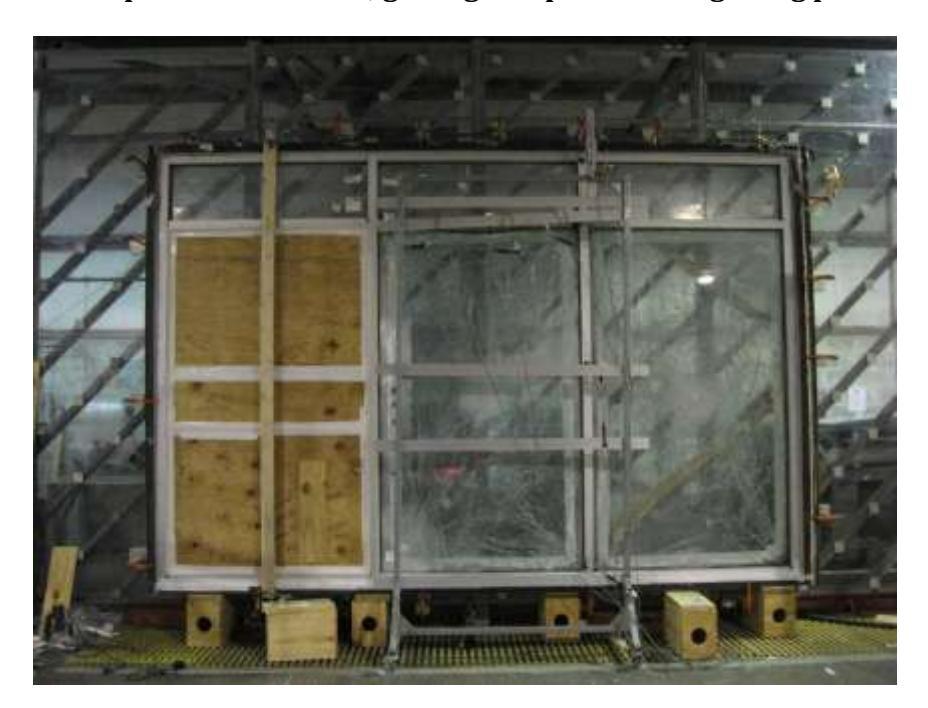
Photo No. 8 Specimens #1, #2, #3 Wood bracing was used on Specimen #1 in order to continue cyclic testing on Specimens #2 and #3

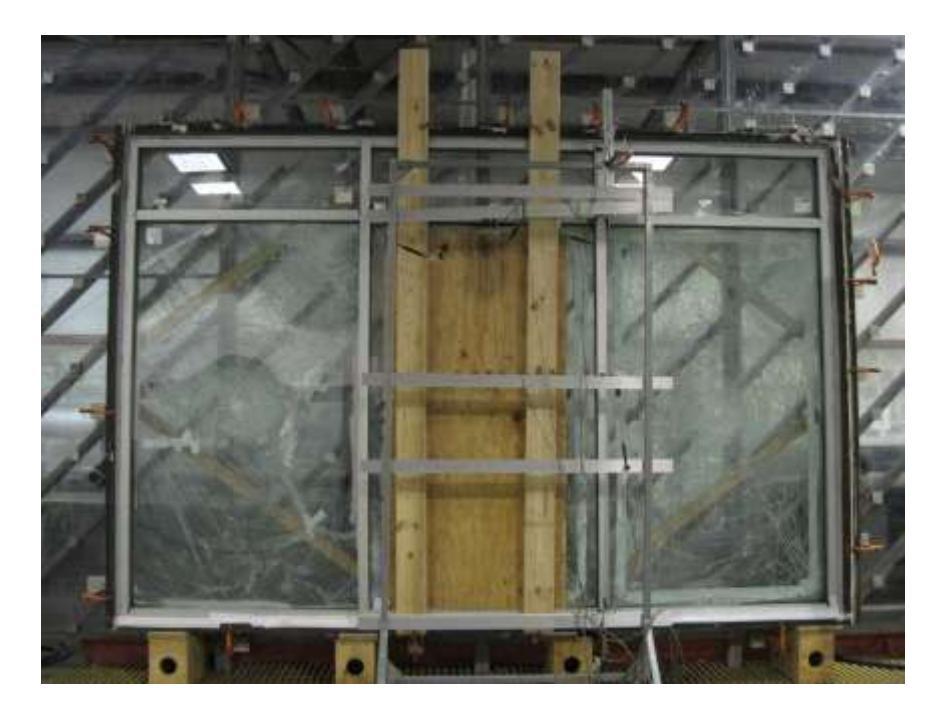
#### Photo No. 9 Specimens #R-1, #2, #3

The glazing in Specimen #1 was removed and replaced; wood bracing was used on Specimen #2 to prevent failure and restart impact and cyclic procedures on Specimen #R-1 at far left.

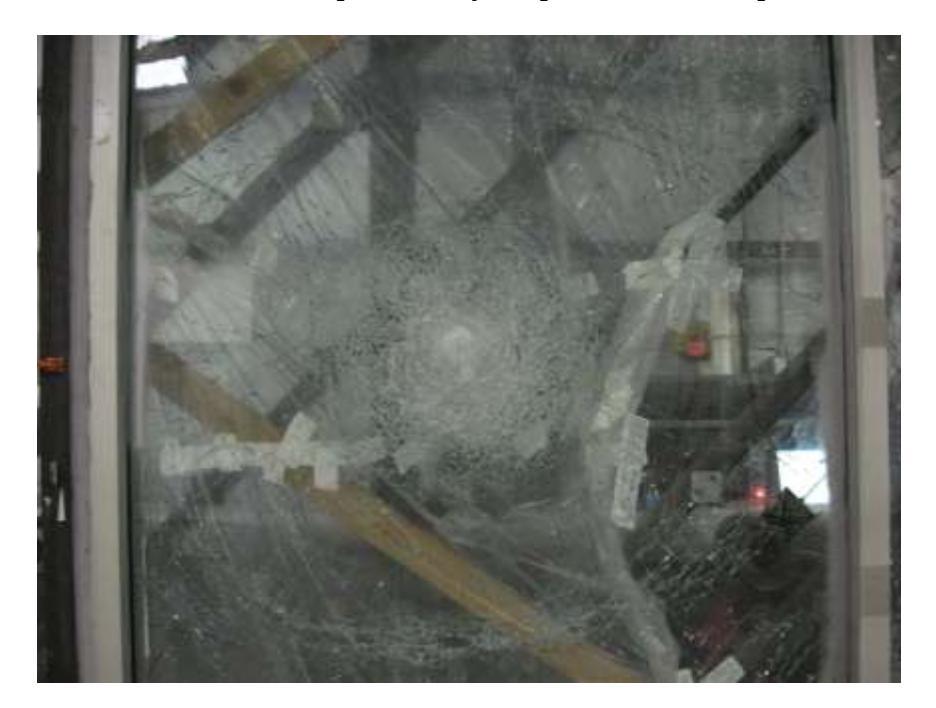
Impact #1: Missile Velocity: 49.4 fps							
Impact Area:	Center midspan of glazing						
<b>Observations</b> :	Missile hit target area, fractured lite; no tears						
Results:	Pass

Photo No. 10 Specimen #R-1 Impact at center midspan

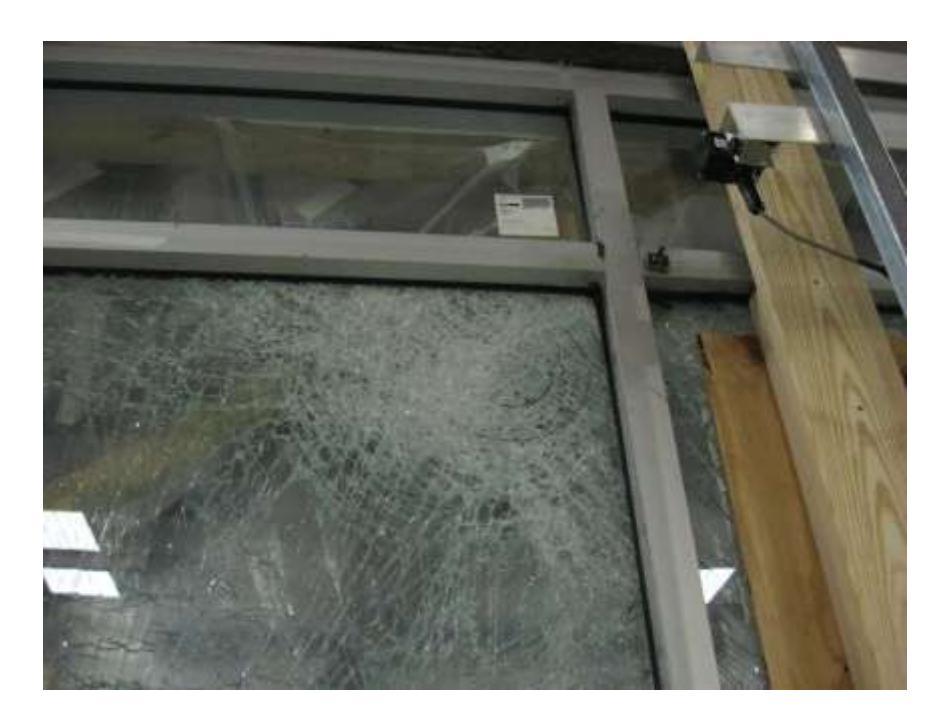
Impact #2: Missile Velocity: 49.3 fps							
Impact Area:	Upper right corner of glazing						
<b>Observations</b> :	Missile hit target area, fractured lite; no tears						
Results:	Pass

Photo No. 11 Specimen #R-1 Impact at upper right corner
