Acoustical Performance Test Report

MANUFACTURE: Coral Architectural Products

SPECIFICATIONS: ASTM E90-09

DESCRIPTION OF SAMPLE	
Model Designation:	Series: FL550T Impact Flush Glaze Store Front
Overall Size:	6'-7" (79") by 6'-7" (79") high
Configuration:	O-O
Weight of Sample:	441 pounds

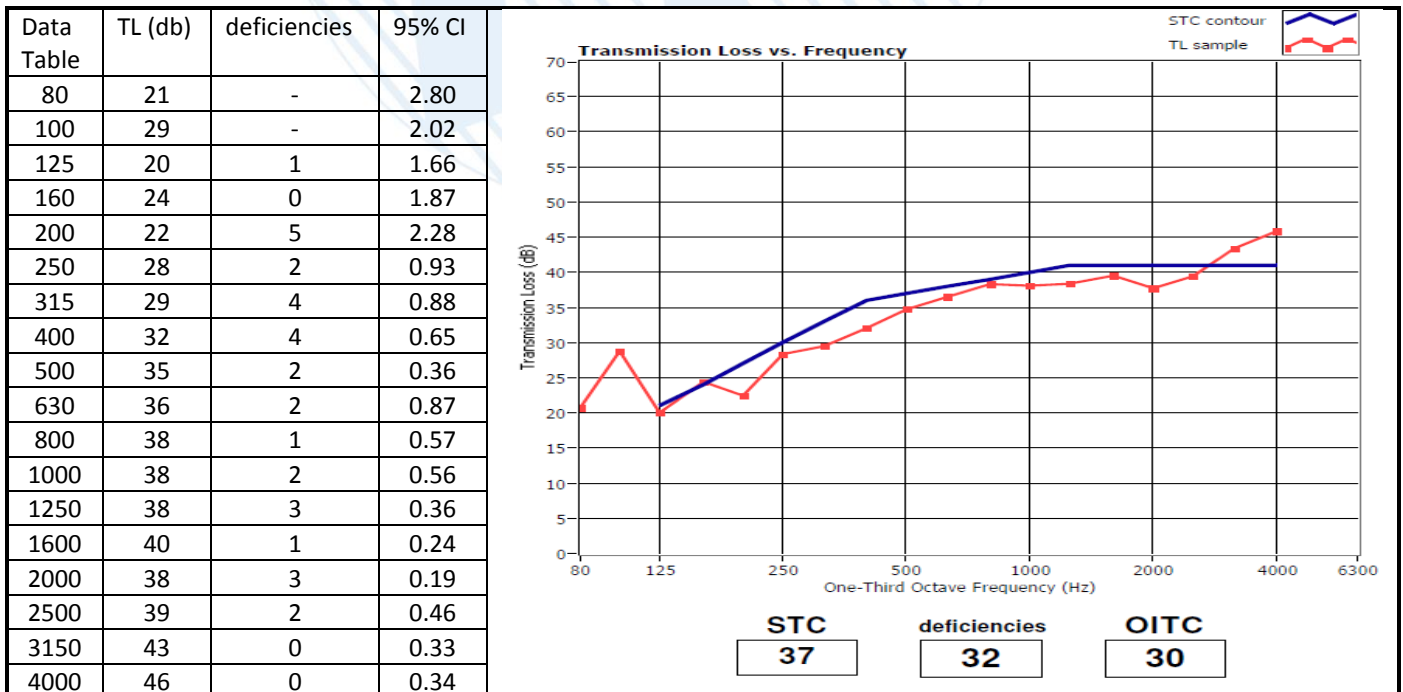
Room Conditions: 25°C R.H: 27% ATM: 1016 hPa
