**MIAMI-DADE COUNTY PERFORMANCE TEST REPORT**

**Report No.:** C3787.01-401-18

CORAL ARCHITECTURAL PRODUCTS  
Tuscaloosa, Alabama

**PRODUCT TYPE:** Aluminum Thermally Broken Flush Glaze  
**SERIES/MODEL:** FL 550T Thermal Impact Storefront System

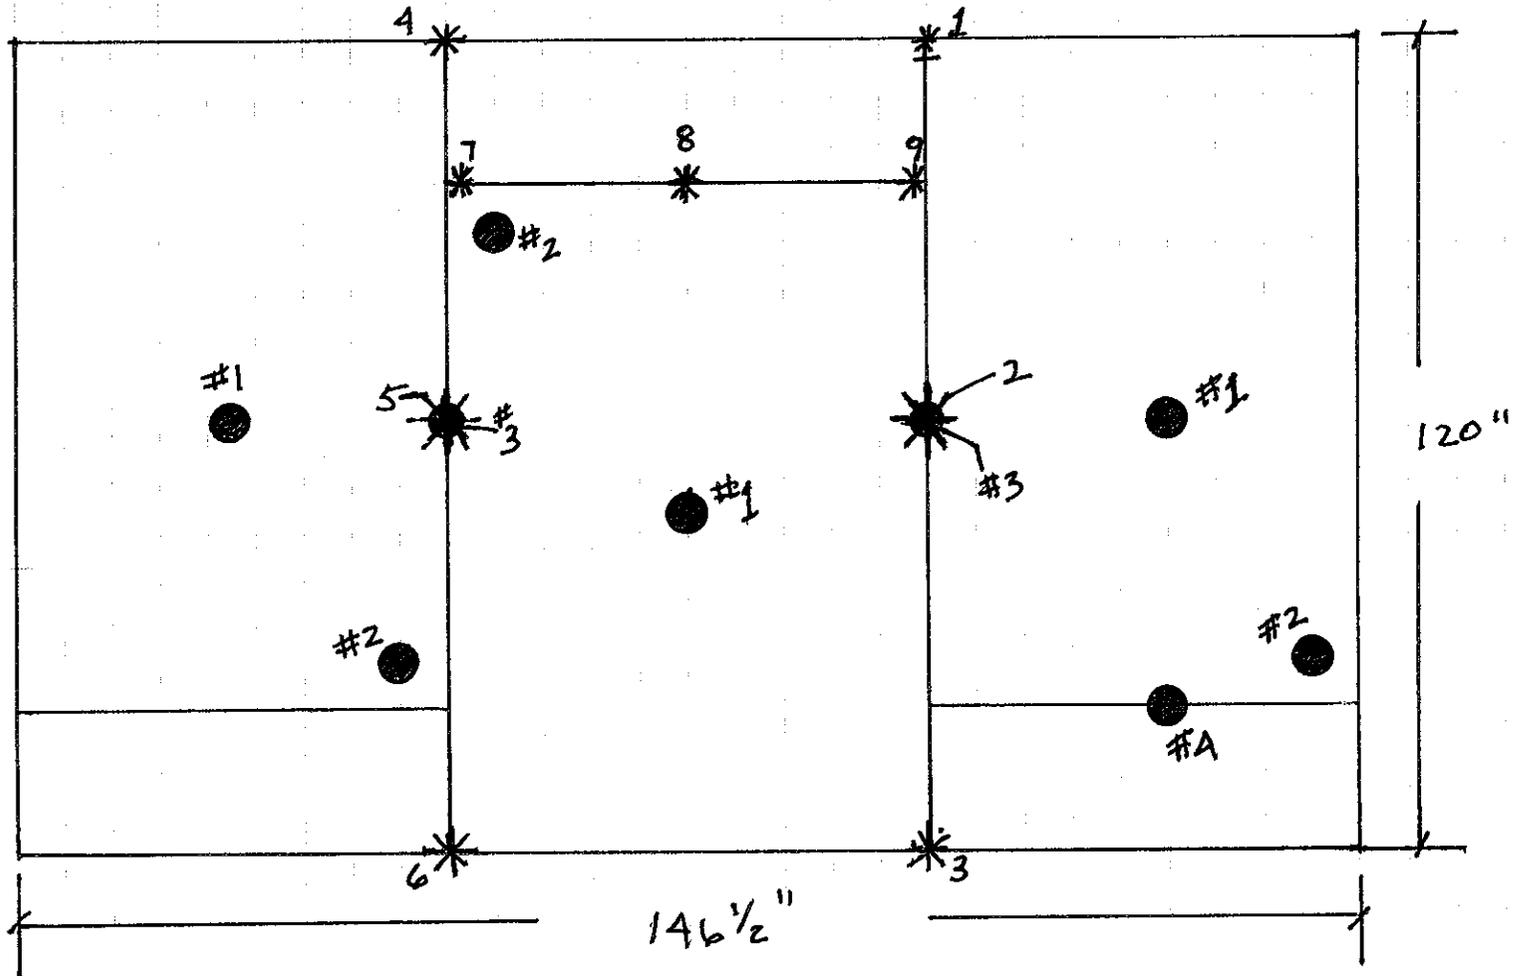
# ATI Sketch # 1

\* - INDICATOR LOCATIONS

● - IMPACT LOCATIONS

**Note:** See Architectural Testing Sketch #1 for indicator locations. Deflection/permanent set reported is the overall deflection between three points (longest unsupported span) which accounts for support movement.

*Note: See Architectural Testing Sketch #1 for impact locations.*

**Note:** See Architectural Testing Sketch #1 for indicator locations. Deflection/permanent set reported is the overall deflection between three points (longest unsupported span) which accounts for support movement. Test Specimens #1, #2 and #3 were cycled in a common chamber.

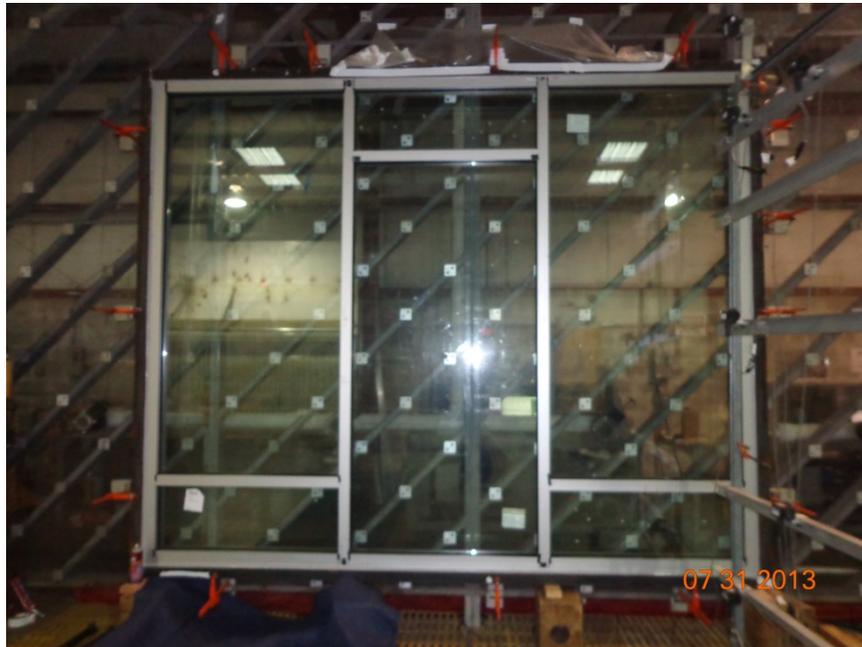
**Photo No. 1**  
**TAS 202 Specimen and TAS 201 and**  
**TAS 203 Specimens #1, 2 and 3**

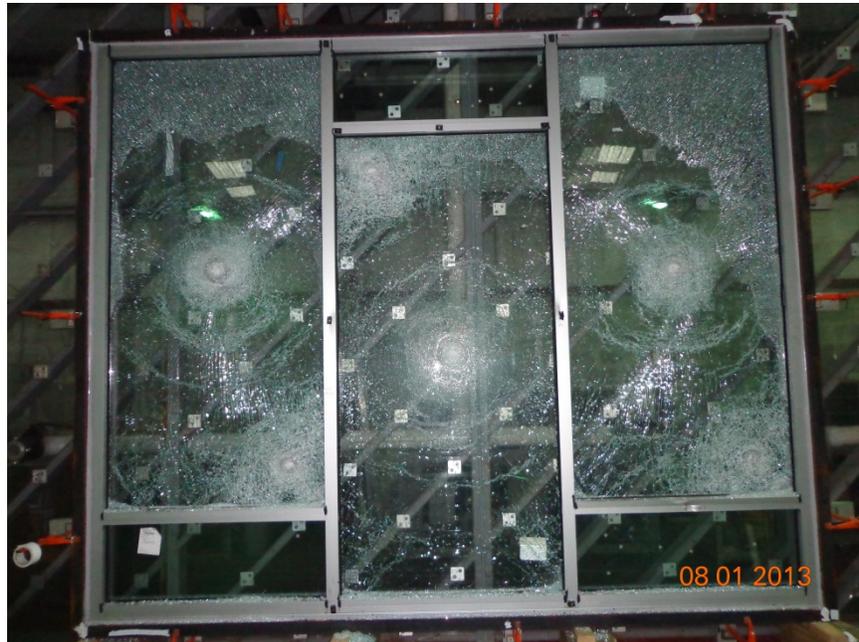
**Photo No. 2**  
**TAS 201 and TAS 203 Specimens #1, 2 and 3**

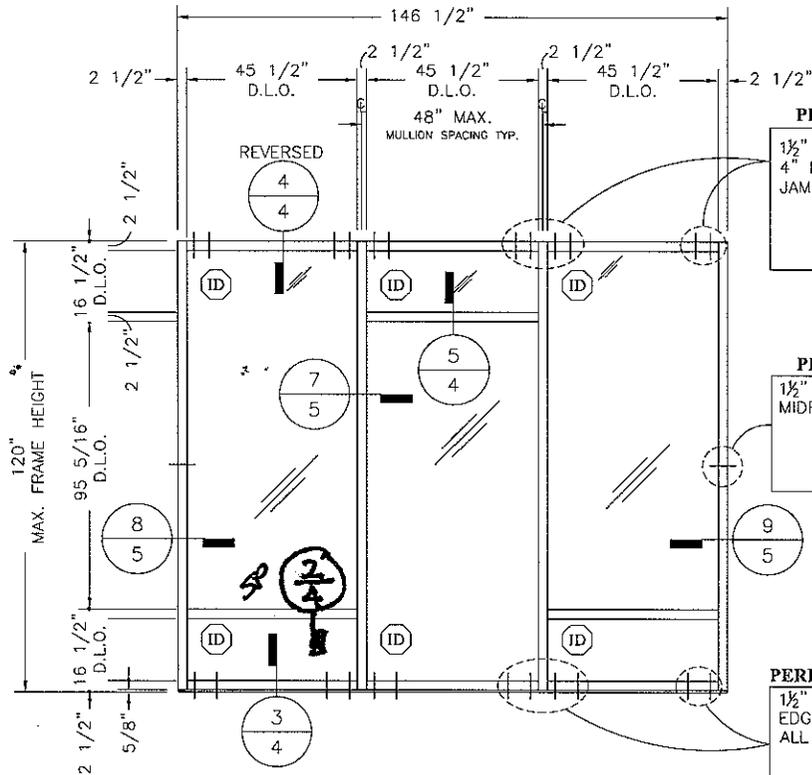
| SHEET 2 OF 7 | | | |

**PERIMETER FASTENERS**  
 1 1/2" X #14 TEK SCREW 2" AND 4" FROM EDGE OF VERTICAL OR JAMB.  
 SP

**PERIMETER FASTENERS**  
 1 1/2" X #14 TEK SCREW AT MIDPOINT.  
 SP

**PERIMETER FASTENERS TO SUBSILL FL539T**  
 1 1/2" X #14 PHSMS 2" AND 4" FROM EDGE OF VERTICAL OR JAMB TYPICAL ALL LOCATIONS  
 SP

FL539T SUB SILL IS ANCHORED AT 4" FROM EACH END AND 24" ON CENTER WITH 1 1/2" X #14 TEK SCREW  
 SP

**E1 - LARGE MISSILE**

WEEP HOLES ON FACE OF FL539T 6 3/4" FROM EDGE OF JAMBS AND VERTICALS 1/4" IN DIAMETER  
 SP

- TESTING:**  
 AIR, WATER, STATIC, IMPACT, AND CYCLE
- MAX. ALLOWABLE DEFLECTION = 0.667"
- DESIGN PRESSURE = +/-55 PSF SP
- WATER TEST AT 15 PSF SP
- AIR @ 6.24 P.S.F. SP

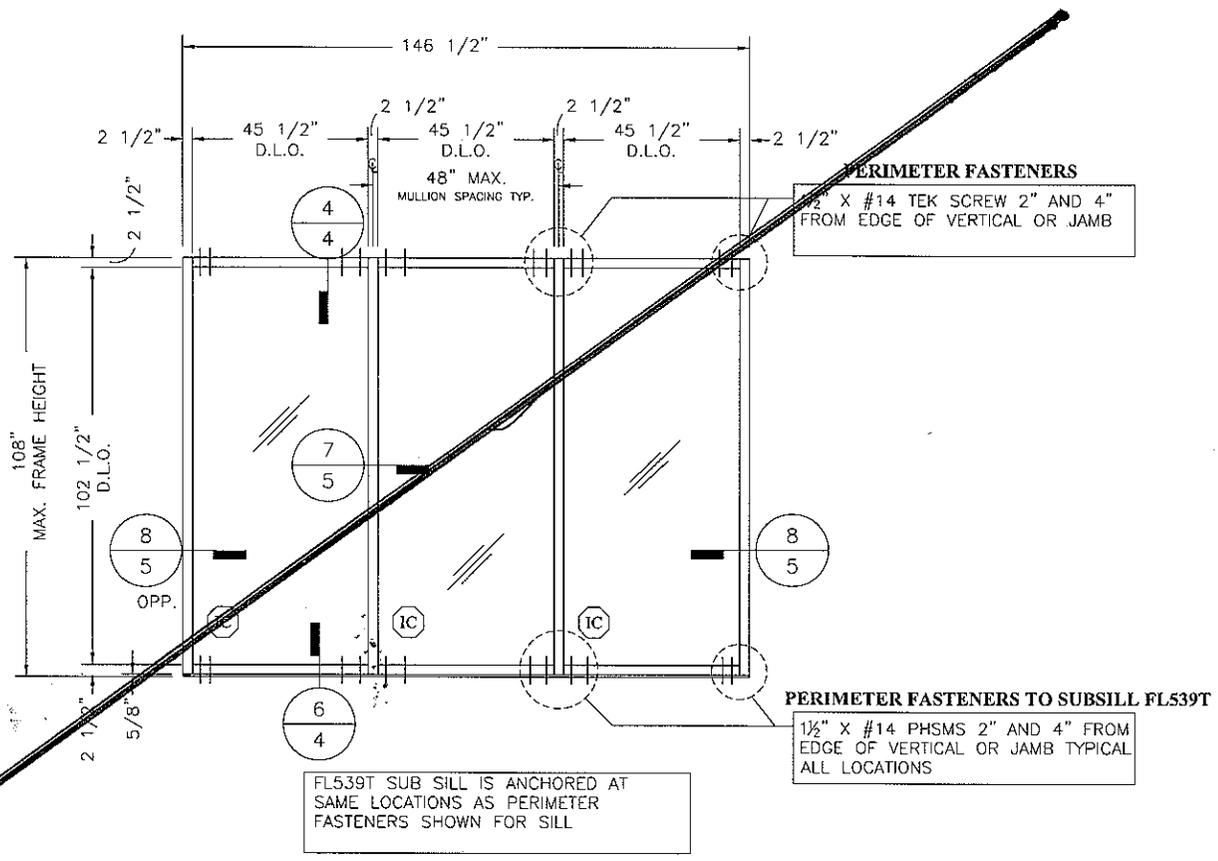
| SHEET | 3 OF 7 | | |

TESTING:  
IMPACT AND CYCLE

DESIGN PRESSURE = +/-55 PSF

STEEL TEST BUCK

WEEP HOLES ON FACE OF FL539T  
6 3/4" FROM EDGE OF JAMBS AND  
VERTICALS 3/8" IN DIAMETER

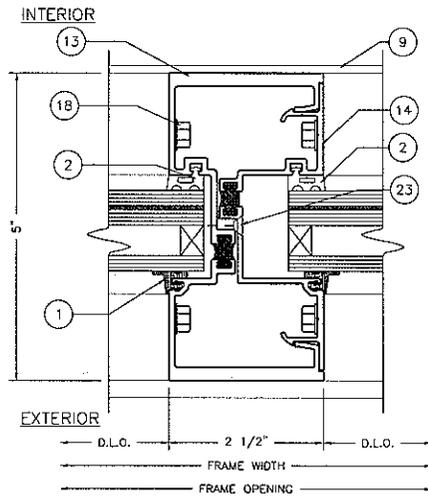
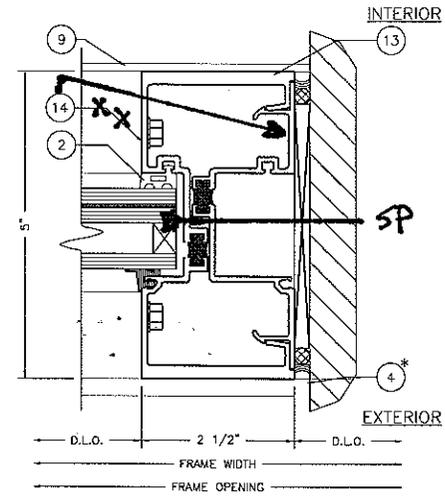
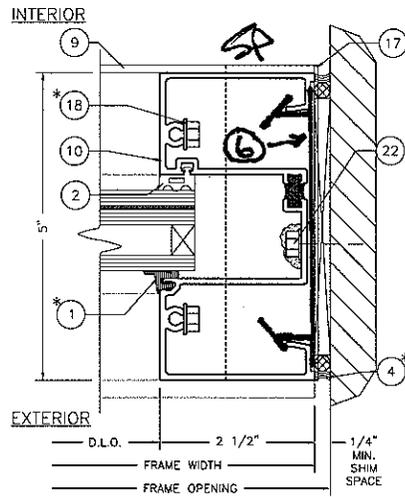
| SHEET 5 OF 7 | | | |

TEST REPORT DRAWINGS FOR  
FL550T WINDOW WALL SYSTEM  
PROTOCOLS: TAS201/202/203  
FRAMING DETAILS

| Frame Member | Part # | Material | Description |
|---|---|---|---|
| Left jamb | FL571T/<br>FL515-1 | Extruded aluminum | Detail #8 on sheet #5 of #7 |
| Right jamb | FL574T/<br>FL575T | Extruded aluminum | Detail #9 on sheet #5 of #7 |
| Vertical mullions | FL574T/<br>FL575T | Extruded aluminum | Detail #7 on sheet #5 of #7 |
