**ASTM E 1886 and ASTM E 1996 TEST REPORT**

**Report No.:** A2657.02-401-44

CORAL ARCHITECTURAL PRODUCTS  
Tuscaloosa, Alabama

**PRODUCT TYPE:** Curtain Wall  
**SERIES/MODEL:** PW257 Dry Glazed

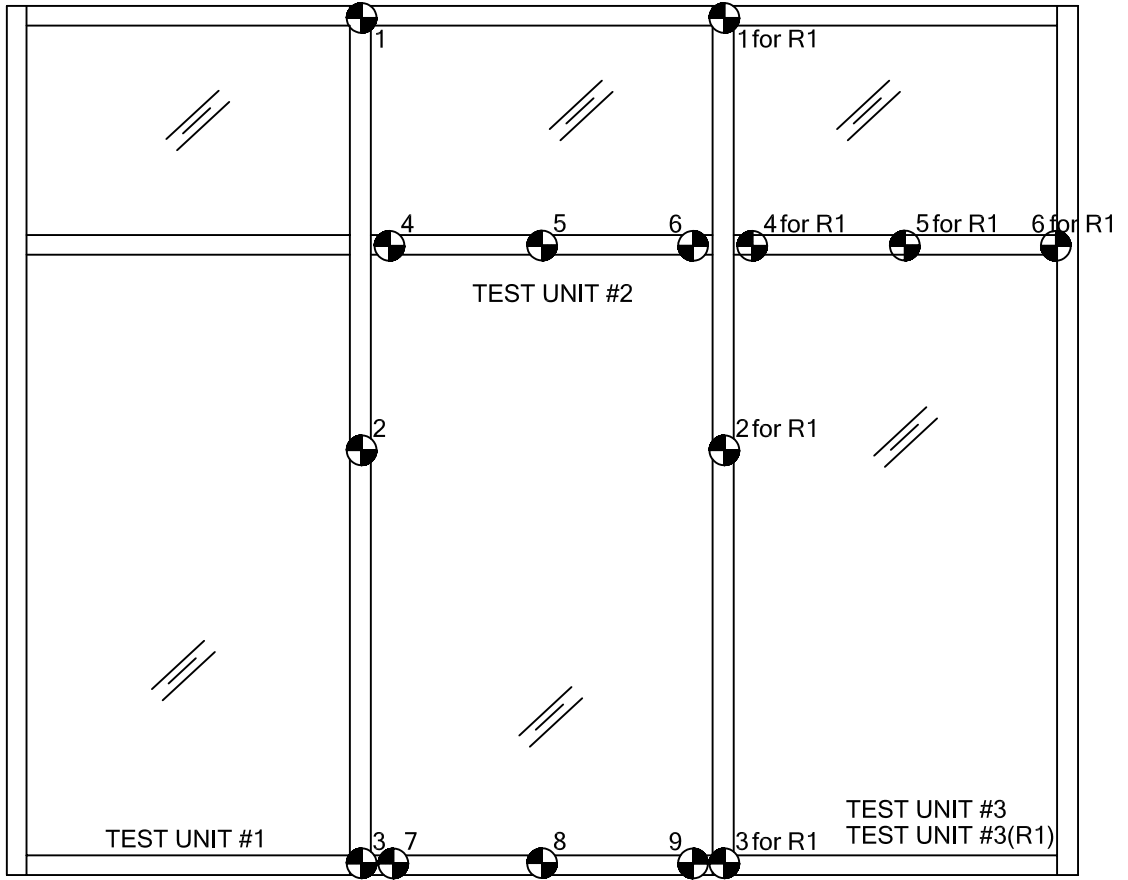
SKETCH #1

## INDICATOR LOCATIONS

**Note:** *See Architectural Testing Sketch #2 for indicator locations. Test Specimens #1, #2 and #3 were cycled in a common chamber.*

**Note:** See Architectural Testing Sketch #2 for indicator locations. Test Specimens #1 and 2 were cycled in a common chamber.

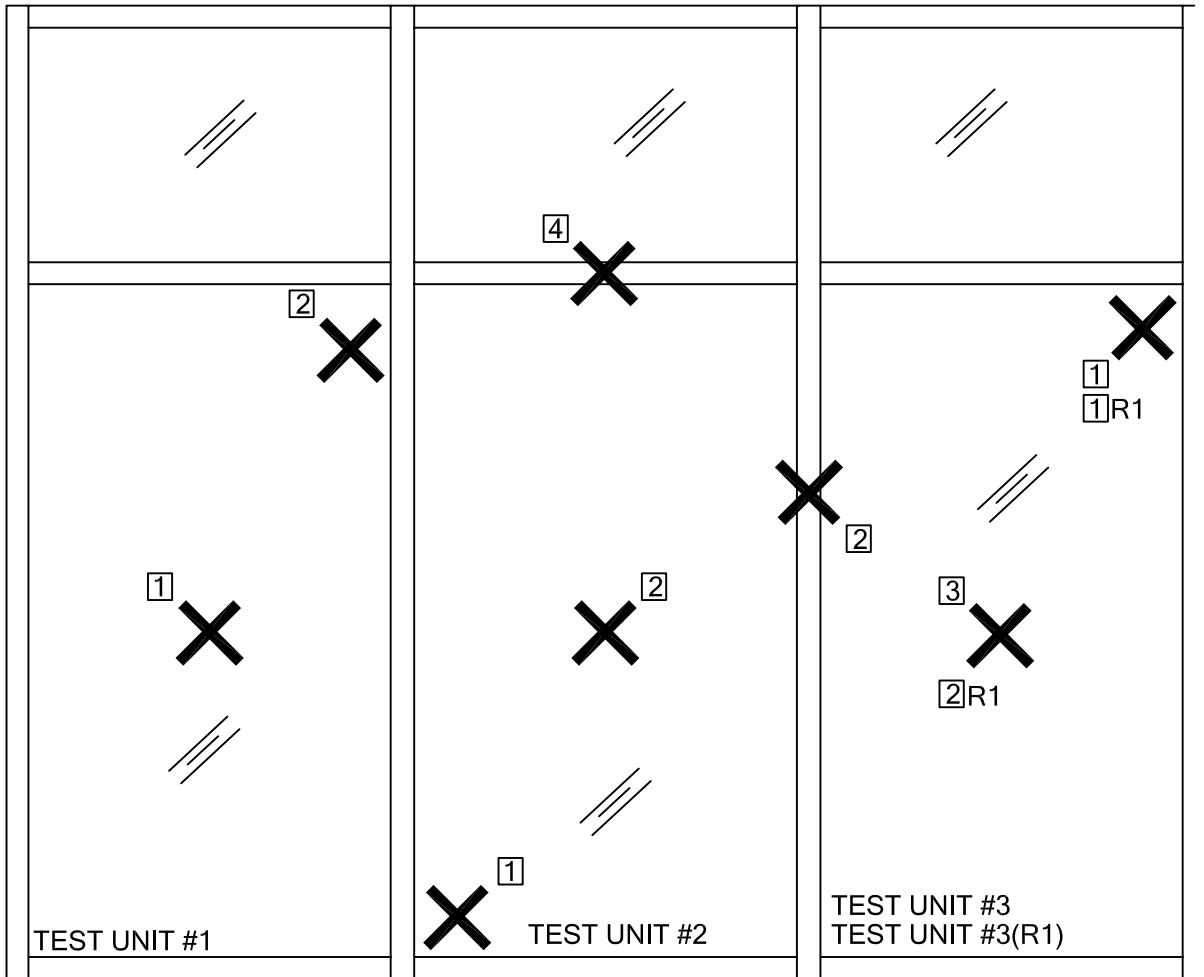
## LARGE MISSILE IMPACT LOCATIONS

*Note: See Architectural Testing Sketch #1 for impact locations.*

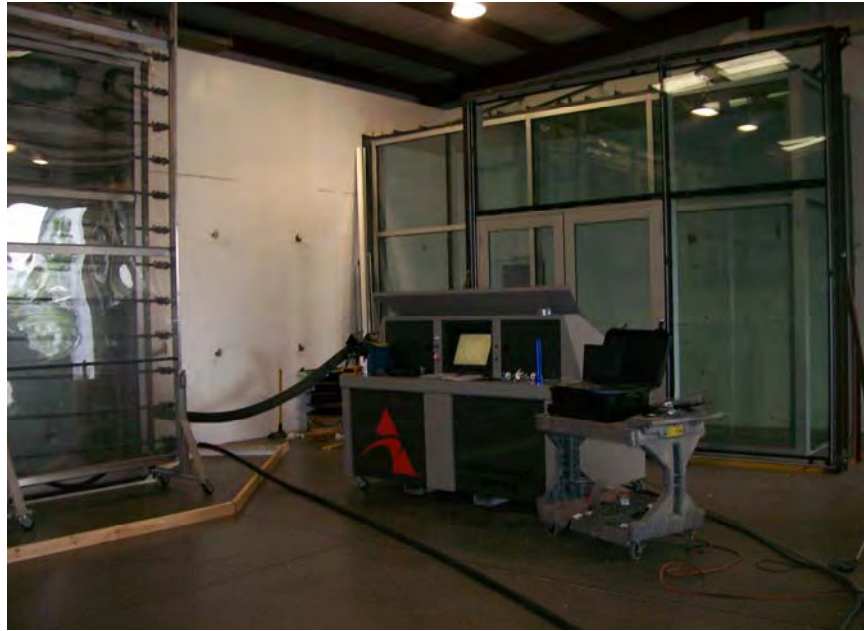
Photo No. 1  
Test equipment,

**Cannon:** Constructed from steel piping utilizing compressed air to propel the missile

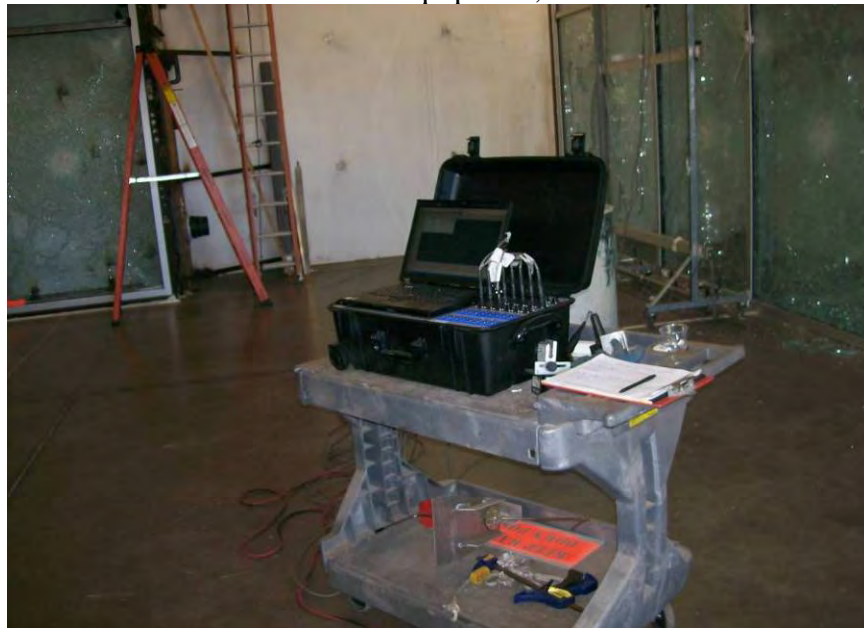
Photo No. 2  
Deflection measuring equipment

**Deflection Measuring Device:** Linear transducers,

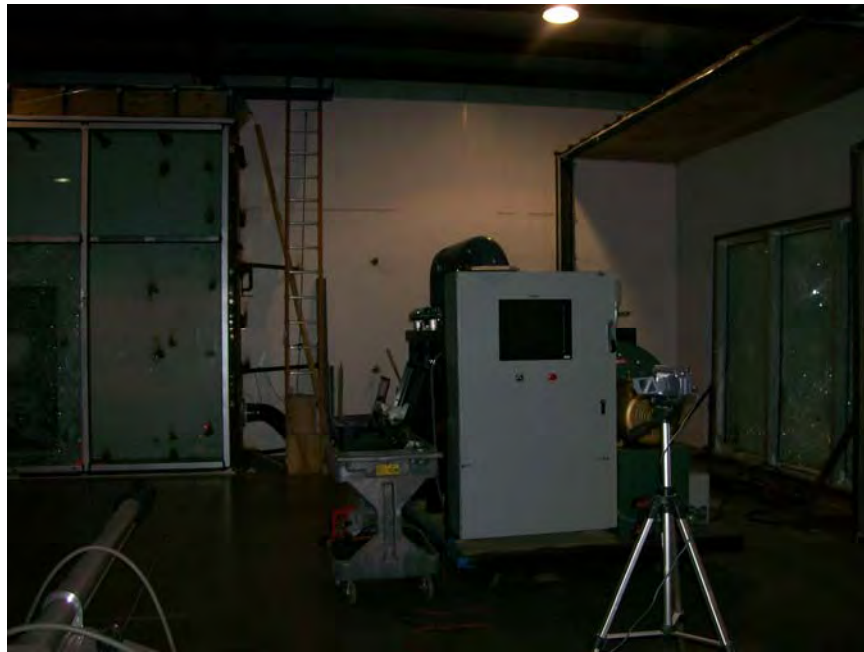
Photo No. 3  
Specimen # 1, 2 and 3  
Cycling equipment set up

**Cycling Mechanism:** Computer controlled centrifugal blower with electronic pressure measuring device

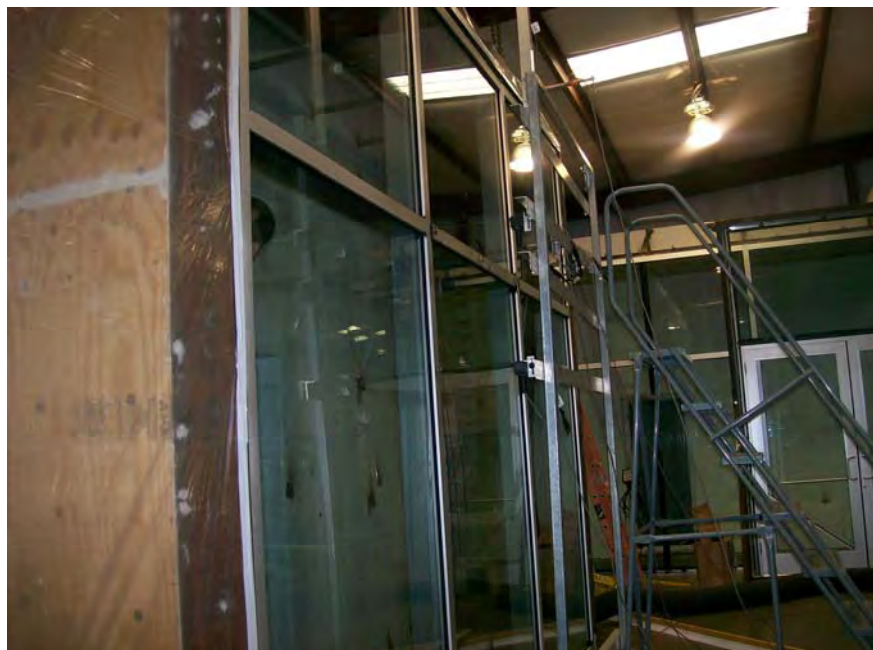
Photo No. 4  
Specimen # 1, 2 and 3  
Set up for test.

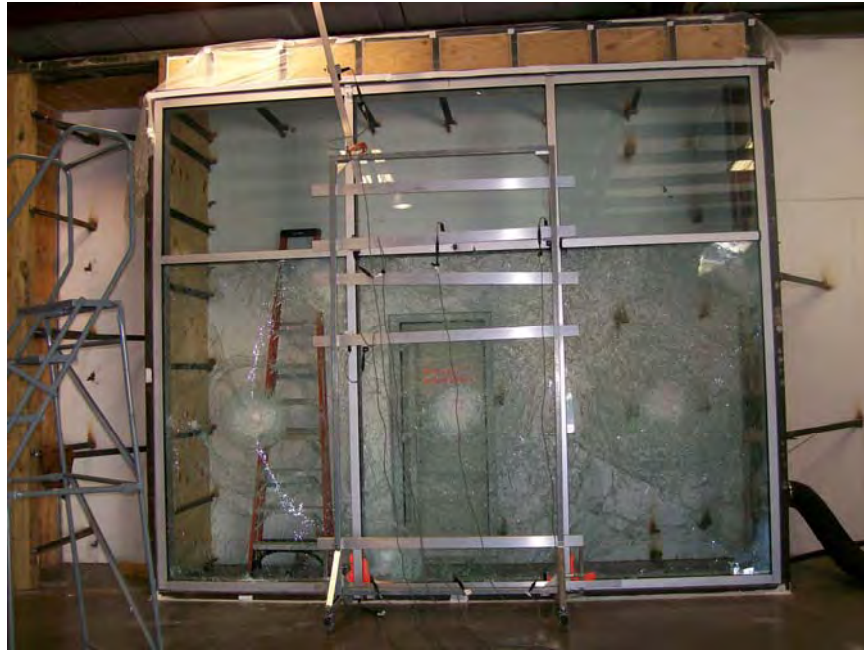
Photo No. 5  
Specimen # 1, 2 and 3  
Impact shots and set up for cyclic pressure test.

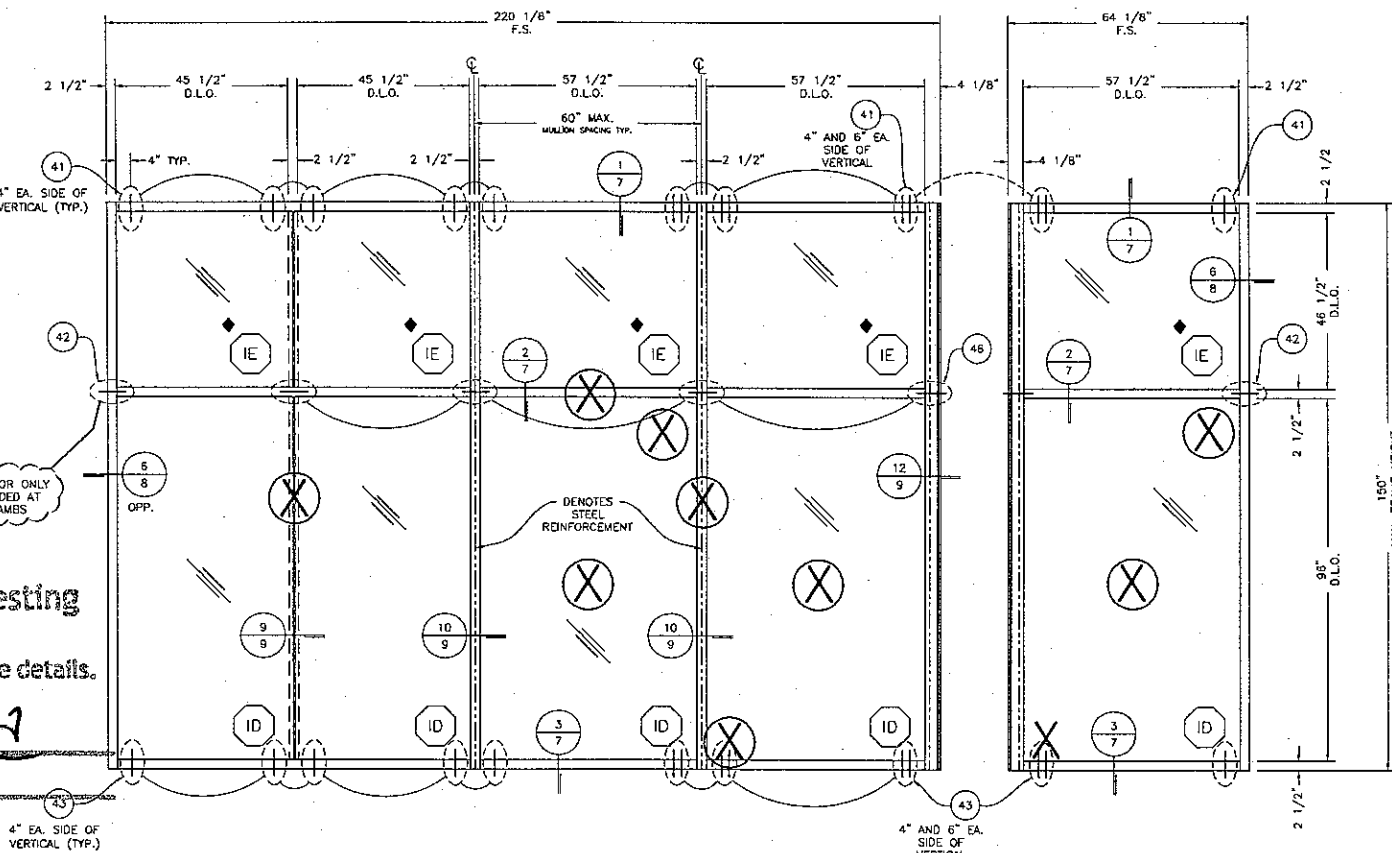
**ELEVATION E1**  
**CAPTURED & B.G. MULLIONS -LONG SPAN-**  
**WITH SR150 & 1/2\"x 3-3/4\" BAR**  
**STEEL REINFORCEMENT**

TESTING:  
AIR, WATER, STATIC, IMPACT, AND CYCLE

MAX. ALLOWABLE DEFLECTION (L/180)= 0.833

DESIGN PRESSURE = +/- 80 PSF

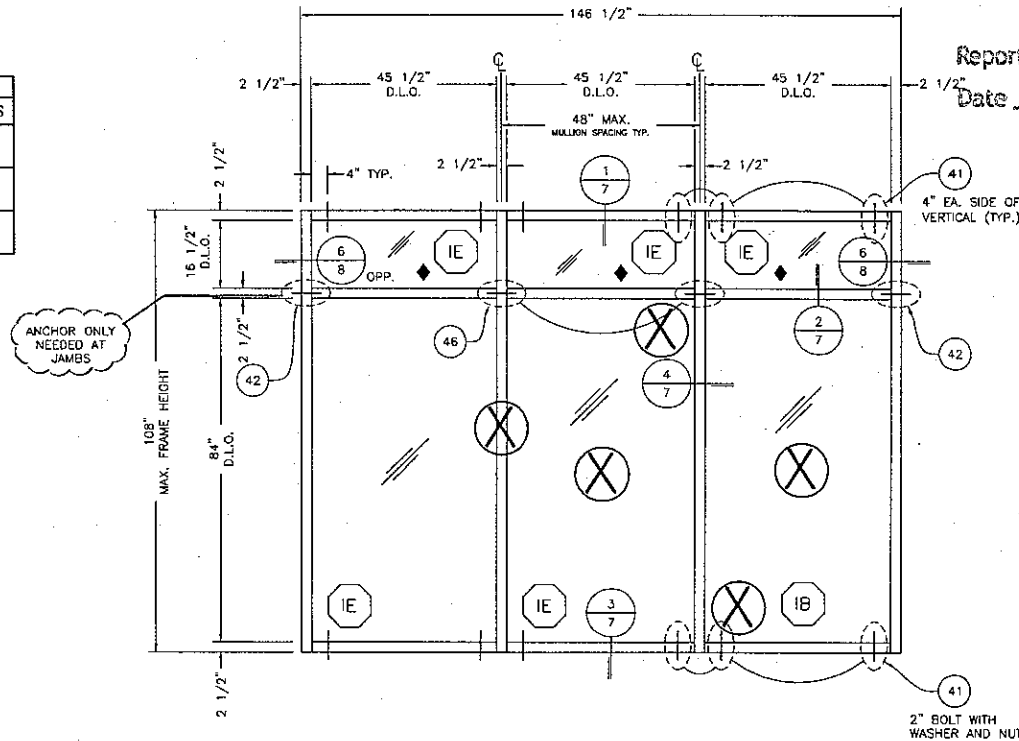
**ELEVATION E2**  
**CAPTURED MULLION -SHORT SPAN-**  
**WITHOUT REINFORCEMENT**

TESTING:  
STATIC, IMPACT, AND CYCLE

MAX. ALLOWABLE DEFLECTION (L/180) = 0.600

DESIGN PRESSURE = +/- 65 PSF

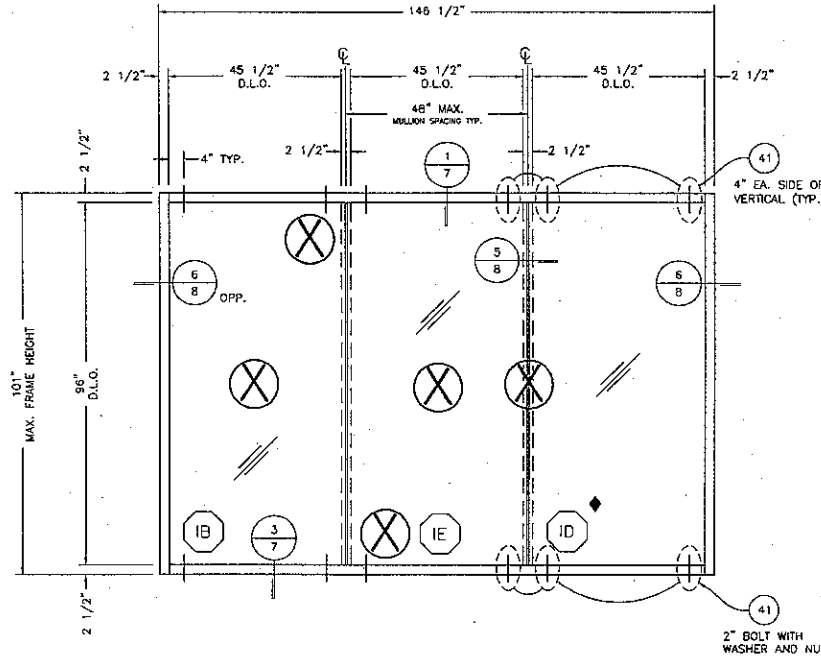
**ELEVATION E3  
B.G. MULLION -SHORT SPAN-  
WITHOUT REINFORCEMENT**

TESTING:  
STATIC, IMPACT, AND CYCLE

MAX. ALLOWABLE DEFLECTION (L/180) = 0.561

DESIGN PRESSURE = +/- 65 PSF

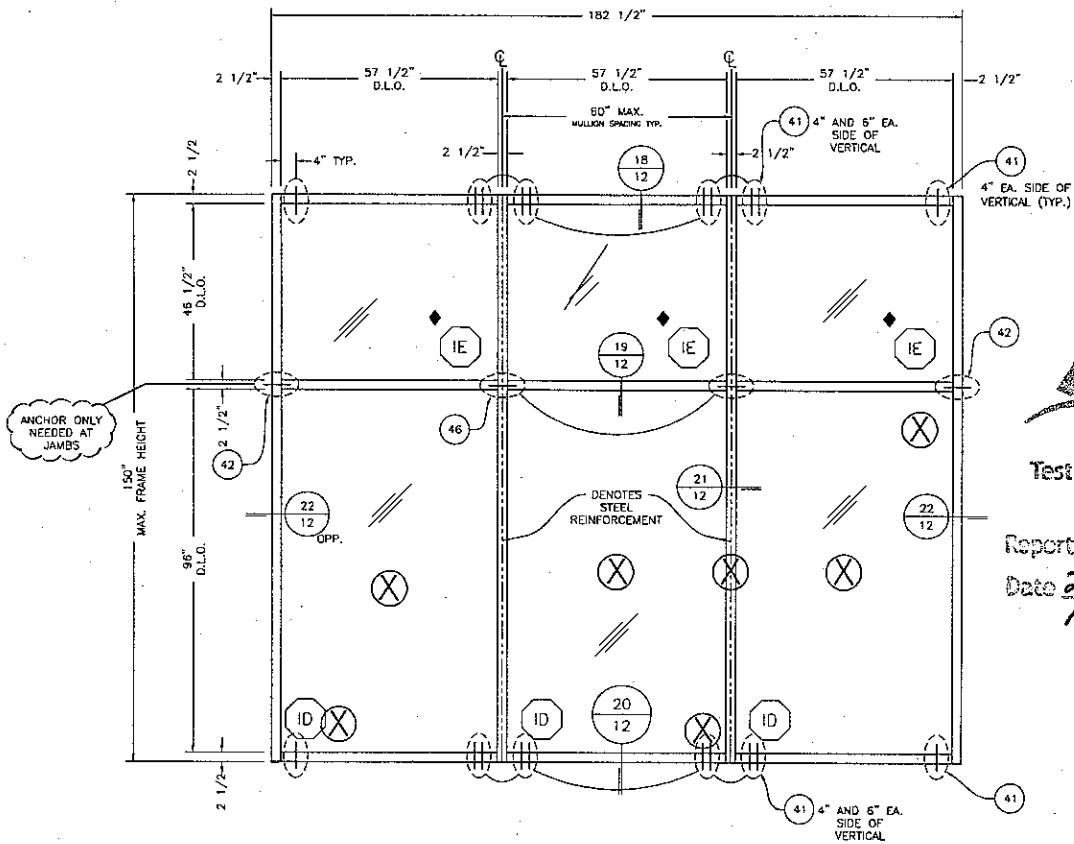
**ELEVATION E4 - DRY GLAZE  
CAPTURED MULLION -LONG SPAN-  
WITH SR150 & 1/2"X 3-3/4" BAR  
STEEL REINFORCEMENT**

TESTING:  
IMPACT, AND CYCLE

MAX. ALLOWABLE DEFLECTION (L/180)= 0.833

DESIGN PRESSURE = +/-80 PSF

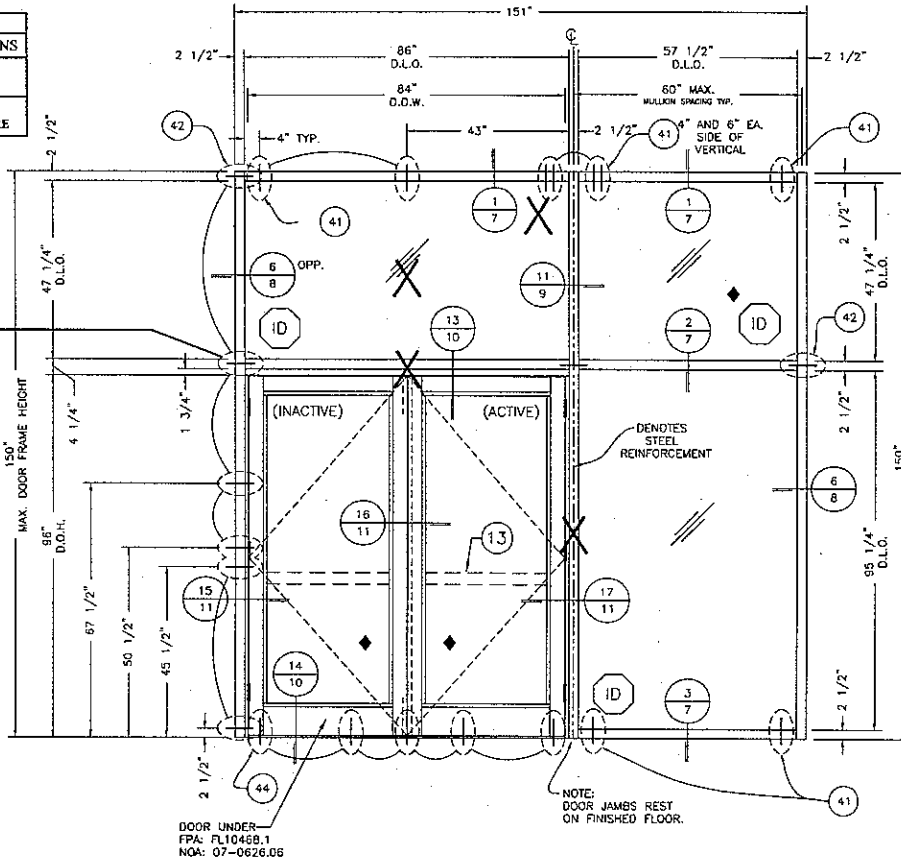
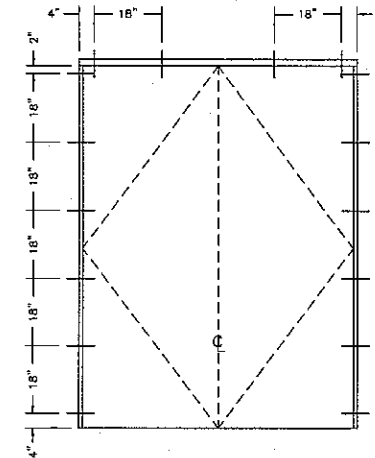
**LOCATIONS FOR  
DOOR SUB-FRAME ATTACHMENT  
TO CURTAIN WALL ALUMINUM**

**ELEVATION E5  
CAPTURED MULLION -LONG SPAN-  
WITH SR150 & 3/4"x 3-3/4" BAR STEEL REINFORCEMENT  
FOR SERIES 381 ENTRANCE DOORS**

TESTING:  
IMPACT, AND CYCLE

MAX. ALLOWABLE DEFLECTION (L/180) = 0.833

DESIGN PRESSURE = +/- 80 PSF

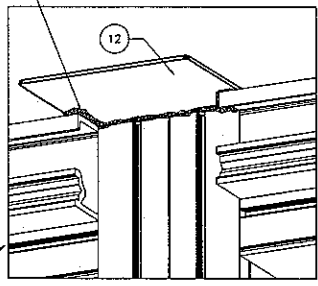
12 TOP SHOWN  
CLOSURE CAP  
(BOTTOM SIMILAR)
