**PERFORMANCE
TEST REPORT**

Report No.: A2658.02-401-44

PRODUCT TYPE: Aluminum Curtain Wall with Transom, Stacked Side-lite and Blanked-out Double Doors

SERIES/MODEL: PW257

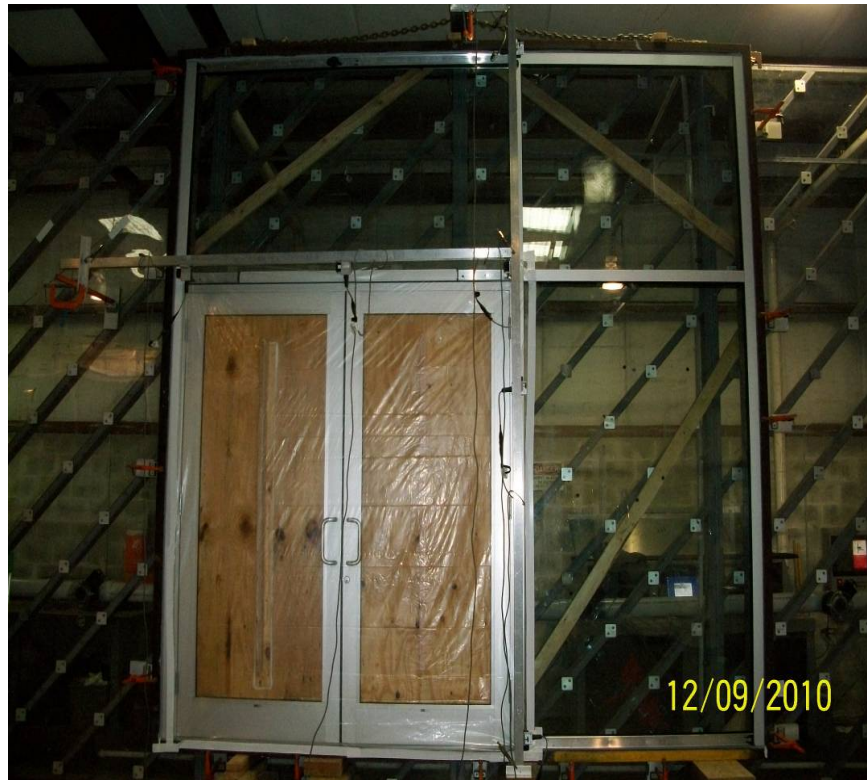
Photo No. 1
Elevation E5
Reinforced Captured Mullion with Series 381 Entrance Door

Impact #1: Missile Velocity: 15.2 m/s (49.8 fps)	
Impact Area:	Mid-span of horizontal mullion at transom.
Observations:	Missile hit target area, fractured outboard lite and dented aluminum cover cap and pressure plate.
Results:	Pass

Impact #2: Missile Velocity: 15.3 m/s (50.2 fps)	
Impact Area:	Mid-span of vertical mullion.
Observations:	Missile hit target area, dented aluminum cover cap and pressure plate.
Results:	Pass

Observations: Two (2) #12 x 1-1/4" flat head screws sheared at the threshold; no deglazing was observed.

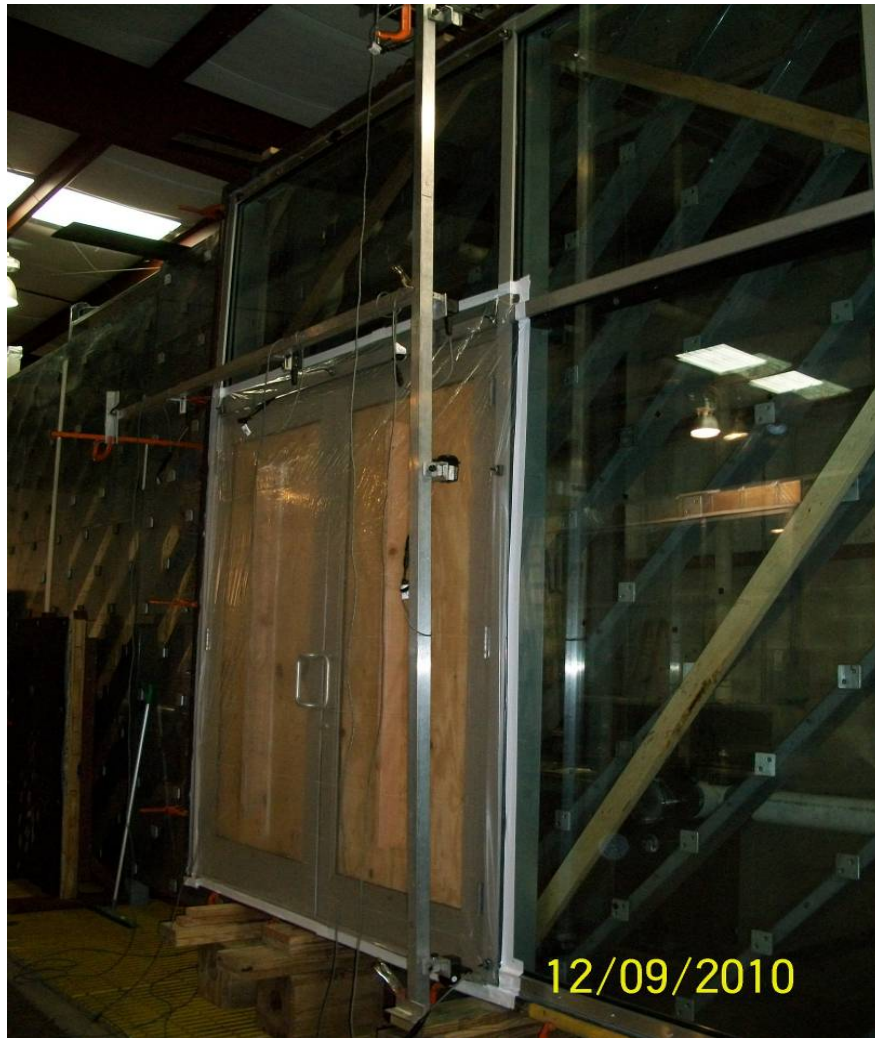
Photo No. 2
Indicator locations for Elevation E5

Pressure Range Pa (psf)	Number of Cycles	Average Cycle Time (seconds)	Maximum Deflection at Indicator mm (inches)					
			#1	#2	#3	#4	#5	#6
766 to 1915 (16 to 40)	3500	1.70	7.87 (0.31)	18.29 (0.72)	12.70 (0.50)	7.11 (0.28)	15.24 (0.60)	18.54 (0.73)
0 to 2298 (0 to 48)	300	6.54	10.92 (0.43)	20.83 (0.82)	14.99 (0.59)	8.13 (0.32)	17.78 (0.70)	21.34 (0.84)
1915 to 3064 (40 to 64)	600	2.07	13.46 (0.53)	25.91 (1.02)	18.03 (0.71)	10.41 (0.41)	22.86 (0.90)	26.16 (1.03)
1149 to 3830 (24 to 80)	100	4.91	16.00 (0.63)	31.24 (1.23)	20.32 (0.80)	12.19 (0.48)	27.69 (1.09)	31.50 (1.24)
			Permanent Set mm (inches)					
			8.64 (0.34)	9.40 (0.37)	12.19 (0.48)	4.32 (0.17)	6.35 (0.25)	9.65 (0.38)

Pressure Range Pa (psf)	Number of Cycles	Average Cycle Time (seconds)	Maximum Deflection at Indicator mm (inches)					
			#1	#2	#3	#4	#5	#6
1149 to 3830 (24 to 80)	50	6.20	13.21 (0.52)	30.23 (1.19)	14.73 (0.58)	11.43 (0.45)	26.67 (1.05)	27.69 (1.09)
1915 to 3064 (40 to 64)	1050	2.61	11.18 (0.44)	24.89 (0.98)	12.95 (0.51)	9.40 (0.37)	24.13 (0.95)	24.13 (0.95)
0 to 2298 (0 to 48)	50	6.26	10.16 (0.40)	21.84 (0.86)	12.19 (0.48)	6.86 (0.27)	18.54 (0.73)	18.54 (0.73)
766 to 1915 (16 to 40)	3350	3.12	8.13 (0.32)	19.56 (0.77)	11.43 (0.45)	6.10 (0.24)	15.49 (0.61)	15.75 (0.62)
			Permanent Set mm (inches)					
			1.02 (0.04)	0.51 (0.02)	3.81 (0.15)	0.76 (0.03)	1.78 (0.07)	1.78 (0.07)

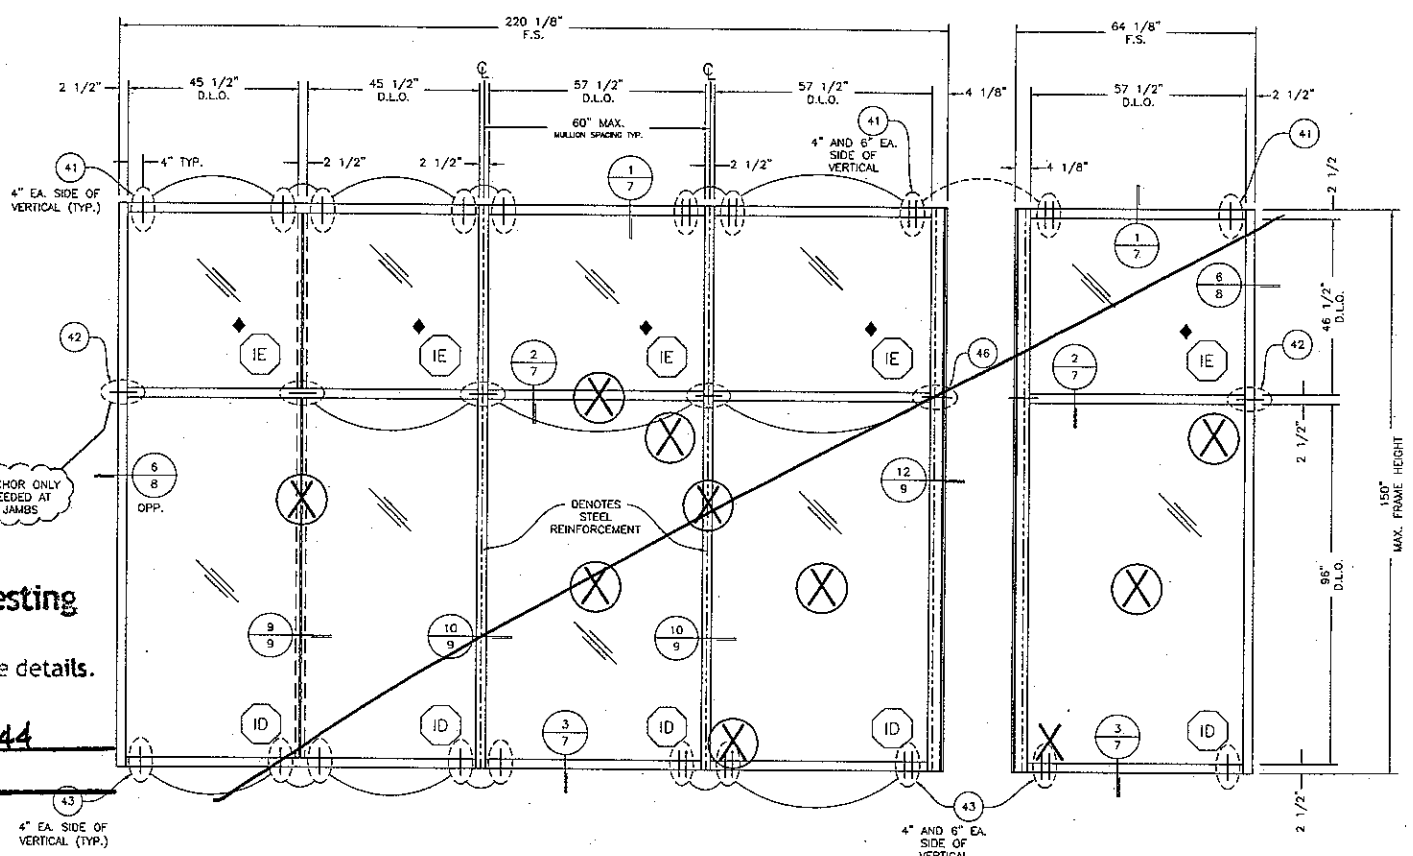
ELEVATION ET
CAPTURED & B.G. MULLIONS -LONG SPAN-
WITH SR150 & 1/2\"x 3-3/4\" BAR
STEEL REINFORCEMENT

- (X) = LARGE MISSILE IMPACT LOCATIONS
- ◆ = INFILL ONLY (DO NOT IMPACT)

SPECIMEN #E1	
TEST METHOD	TEST CONDITIONS
AIR INFILTRATION TEST (ASTM E283 AND TAS 203)	1.57 PSF @ 6.24 PSF
WATER INFILTRATION TEST (ASTM E331 AND TAS 203)	20.00 PSF
UNIFORM STATIC LOAD TEST (ASTM E330 AND TAS 202)	+/- 80 PSF DESIGN PRESSURE
LARGE MISSILE IMPACT TEST (ASTM F1886/F1996 AND TAS 201)	9-LB 40Z, 2x4 @ 50FT/SEC
CYCLIC LOAD TEST (ASTM F1996 AND TAS 203)	+/- 80 PSF DESIGN PRESSURE

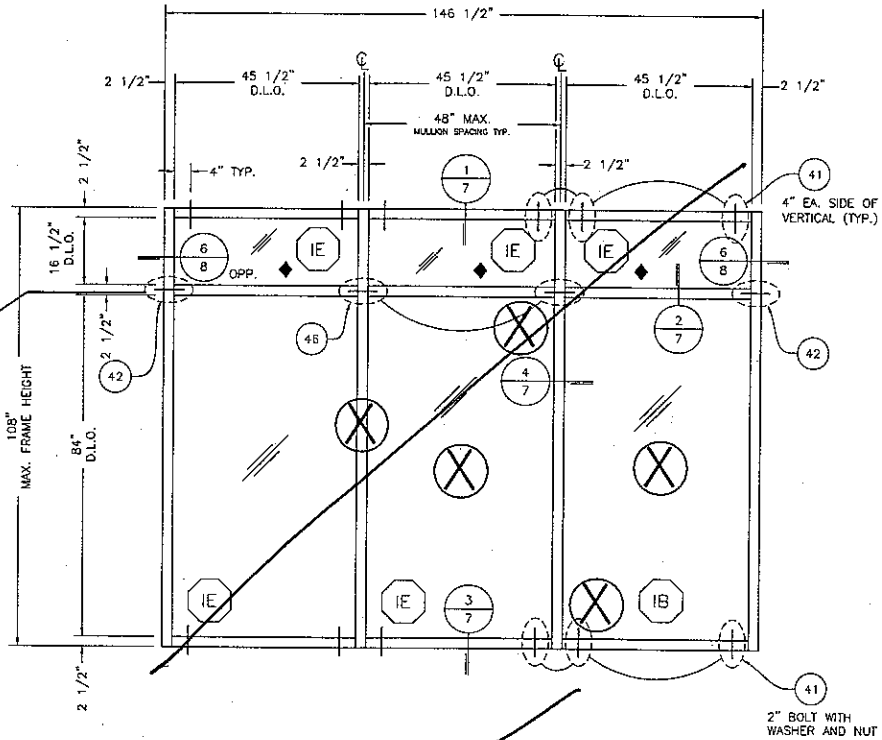
ELEVATION. E2
CAPTURED MULLION -SHORT SPAN-
WITHOUT REINFORCEMENT

MAX. ALLOWABLE DEFLECTION (L/180) = 0.600

DESIGN PRESSURE = +/- 65 PSF

- = LARGE MISSILE IMPACT LOCATIONS
- = INFILL ONLY (DO NOT IMPACT)

SPECIMEN #E2	
TEST METHOD	TEST CONDITIONS
UNIFORM STATIC LOAD TEST (ASTM E330 AND TAS 202)	+/- 65 PSF DESIGN PRESSURE
LARGE MISSILE IMPACT TEST (ASTM E1886/E1996 AND TAS 201)	9-LB 40Z, 2x4 @ 50FT/SEC
CYCLIC LOAD TEST (ASTM E1996 AND TAS 203)	+/- 65 PSF DESIGN PRESSURE

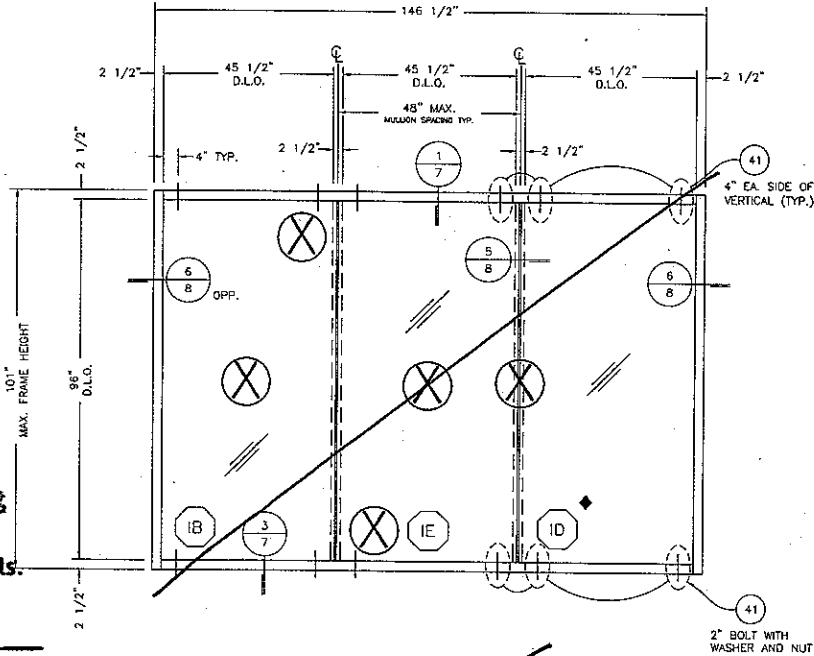
**ELEVATION E3
B.G. MULLION -SHORT SPAN-
WITHOUT REINFORCEMENT**

MAX. ALLOWABLE DEFLECTION (L/180) = 0.561

DESIGN PRESSURE = +/- 65 PSF

(X) = LARGE MISSILE IMPACT LOCATIONS

SPECIMEN #E3	
TEST METHOD	TEST CONDITIONS
UNIFORM STATIC LOAD TEST (ASTM E330 AND TAS 202)	+/- 65 PSF DESIGN PRESSURE
LARGE MISSILE IMPACT TEST (ASTM F1886/E1996 AND TAS 201)	9-LB 4OZ. 2x4 @ 50FT/SRC
CYCLIC LOAD TEST (ASTM E1996 AND TAS 202)	+/- 65 PSF DESIGN PRESSURE

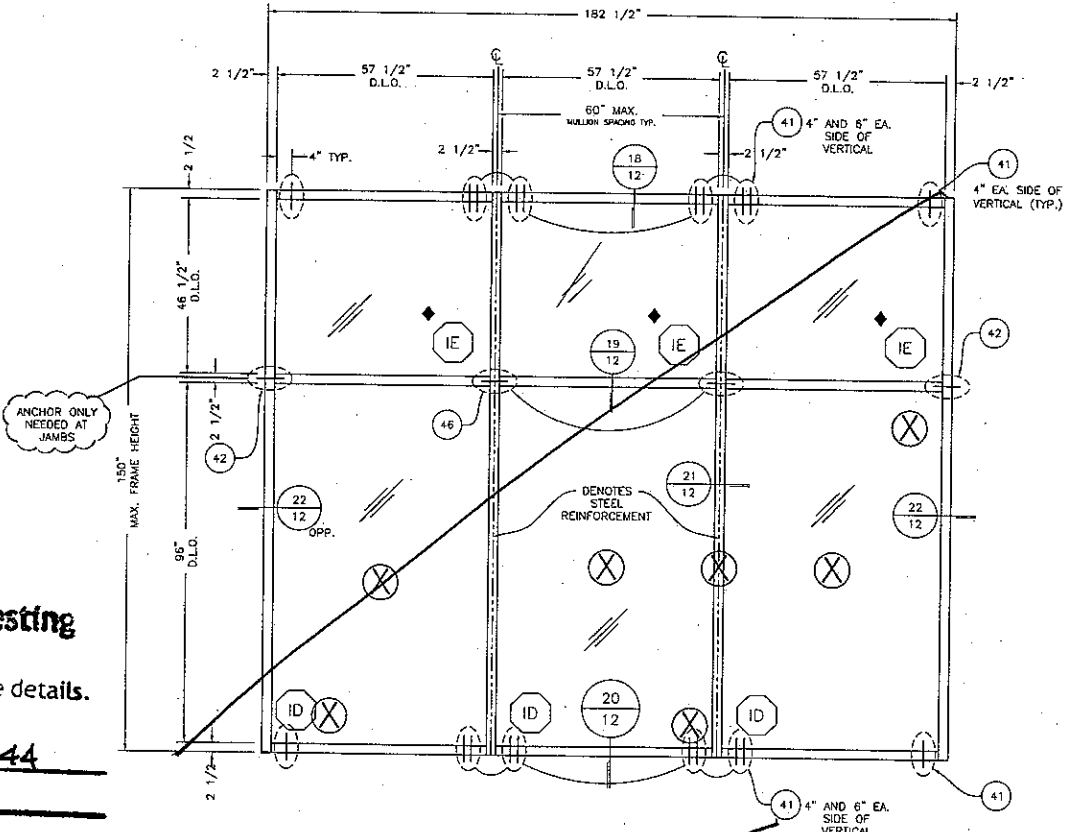
**ELEVATION E4 - DRY GLAZE
CAPTURED MULLION -LONG SPAN-
WITH SR150 & 1/2" X 3-3/4" BAR
STEEL REINFORCEMENT**

MAX. ALLOWABLE DEFLECTION (L/180) = 0.833

DESIGN PRESSURE = +/- 80 PSF

(X) = SMALL MISSILE IMPACT LOCATIONS

SPECIMEN #E1	
TEST METHOD	TEST CONDITIONS
AIR INFILTRATION TEST (ASTM E283 AND TAS 202)	1.57 PSF & 6.24 PSF
WATER INFILTRATION TEST (ASTM E331 AND TAS 202)	20.00 PSF
UNIFORM STATIC LOAD TEST (ASTM E330 AND TAS 202)	+/- 80 PSF DESIGN PRESSURE
LARGE MISSILE IMPACT TEST (ASTM E1886/1996 AND TAS 201)	9-LB 40Z, 2x4 @ 50FT/SEC
CYCLIC LOAD TEST (ASTM E1996 AND TAS 203)	+/- 80 PSF DESIGN PRESSURE

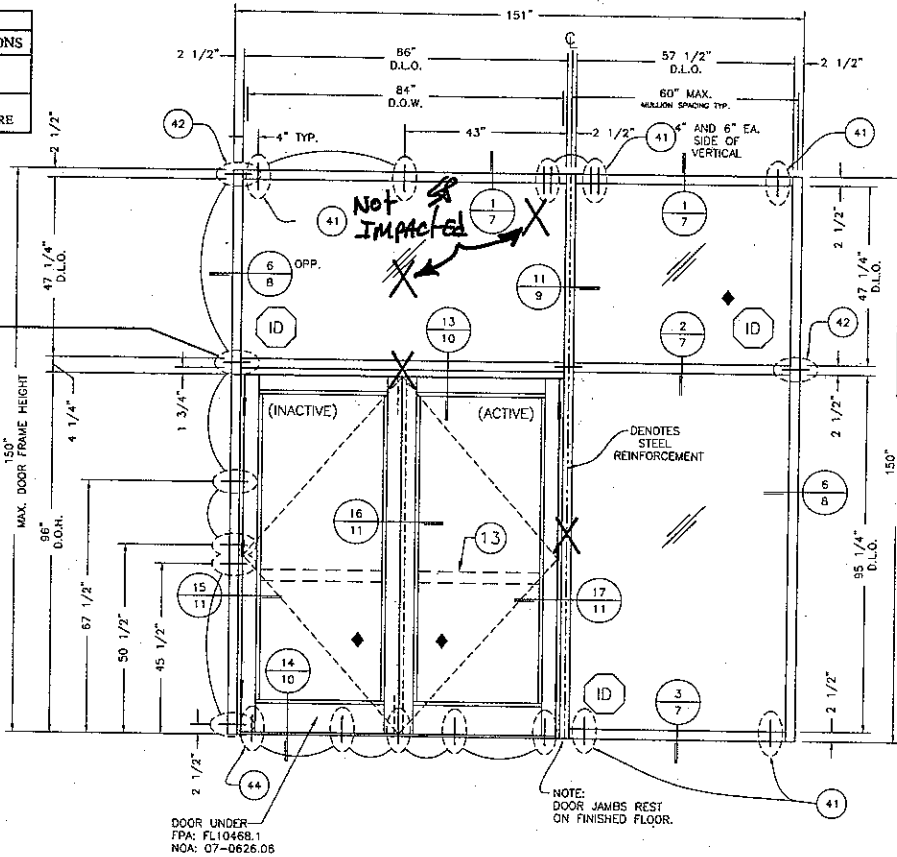
ELEVATION E5
CAPTURED MULLION -LONG SPAN-
WITH SR150 & 3/4" x 3-3/4" BAR STEEL REINFORCEMENT
FOR SERIES 381 ENTRANCE DOORS

MAX. ALLOWABLE DEFLECTION (L/180) = 0.833

DESIGN PRESSURE = +/- 80 PSF

X = LARGE MISSILE IMPACT LOCATIONS

SPECIMEN #E5	
TEST METHOD	TEST CONDITIONS
LARGE MISSILE IMPACT TEST (ASTM E1865/E196 AND TAS 201)	9-LB 4OZ, 2x4 @ 50°F/7SEC
CYCLIC LOAD TEST (ASTM E1996 AND TAS 203)	+/- 80 PSF DESIGN PRESSURE

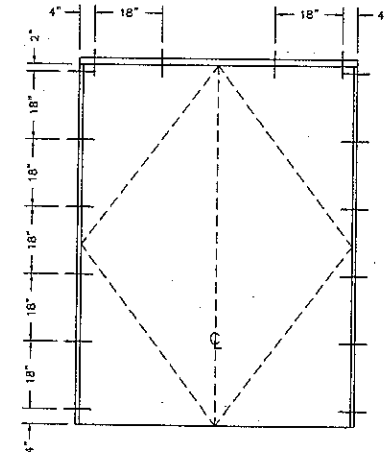
LOCATIONS FOR
DOOR SUB-FRAME ATTACHMENT
TO CURTAIN WALL ALUMINUM

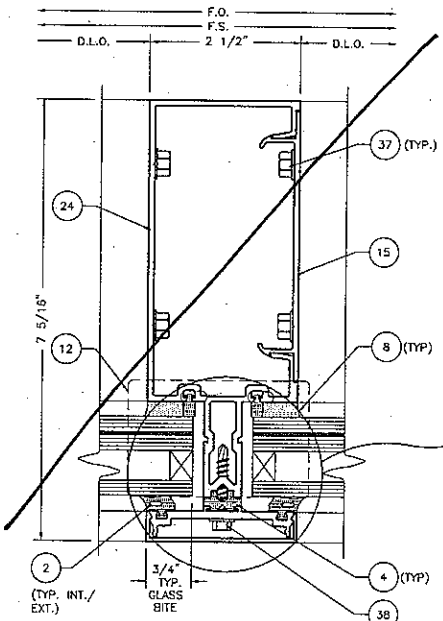
4 - DETAIL
1:2

7 SEAL CONTACT SURFACE W/ DOW 795 BEFORE INSTALLING TOP AND BOTTOM CLOSURE CAP

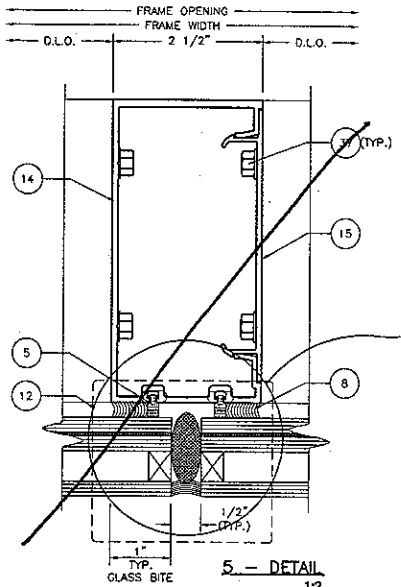
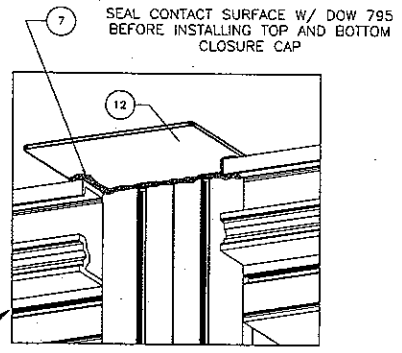
7 CRITICAL SEAL
FILL GASKET REGLET BEHIND END DAM W/ DOW 795

7 CRITICAL SEAL
APPLY DOW 795 SEALANT TO ALL THREE CONTACT SURFACES PRIOR TO INSTALLATION AT HORIZONTALS AND SILL.

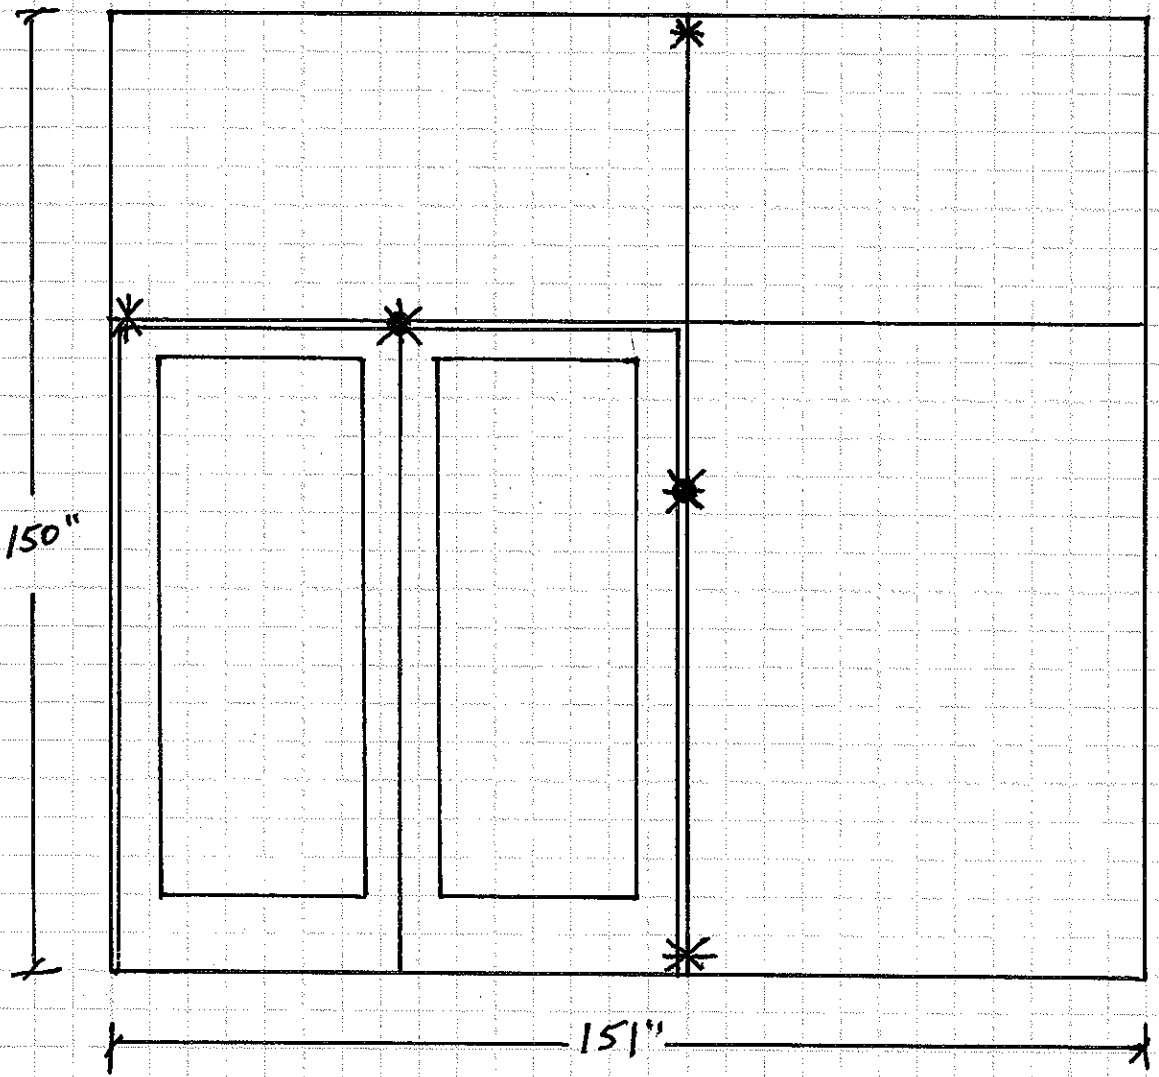
Sketch # 1

ELEVATION ES

- * - INDICATOR LOCATIONS
- - IMPACT LOCATIONS

Note: See Architectural Testing Sketch #1 for impact locations.

Note: See Architectural Testing Sketch #1 for indicator and impact locations.
