MIAMI-DADE COUNTY PERFORMANCE TEST REPORT

Report No.: A2658.01-401-18

CORAL ARCHITECTURAL PRODUCTS Tuscaloosa, Alabama

PRODUCT TYPE: Aluminum Curtain Wall **SERIES/MODEL**: PW257

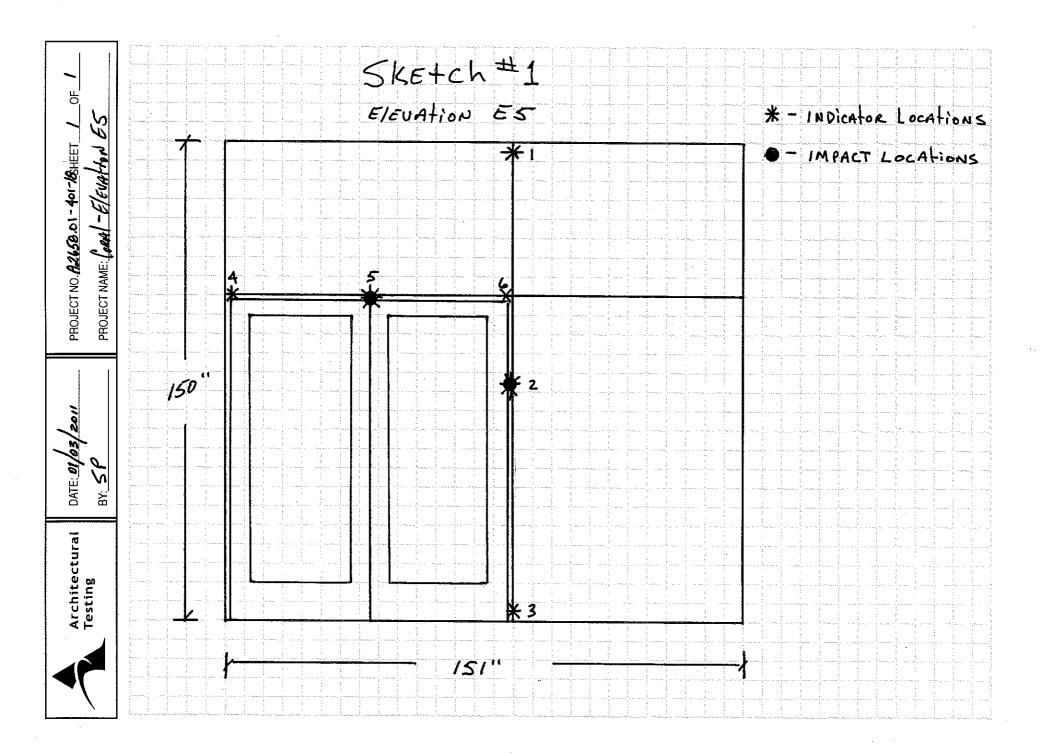
Sketches

Note: See Architectural Testing Sketch #1 for indicator locations.

Note: See Architectural Testing Sketch #1 for impact locations.

Note: See Architectural Testing Sketch #1 for indicator locations.

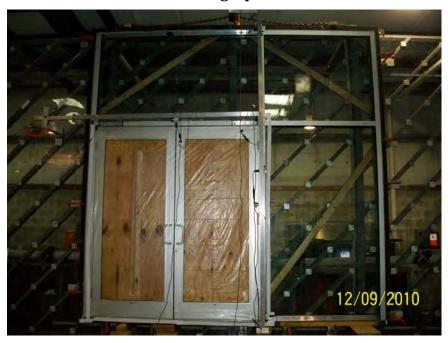
Photo No. 1
Elevation E5
Reinforced Captured Mullion with Series 381 Entrance Door

The specimen was installed into a C-10 steel buck. (See Drawing # Elevation E5) The rough opening allowed for a 1/2" shim space. The interior and exterior perimeter of the unit was sealed with Dow Corning 795.

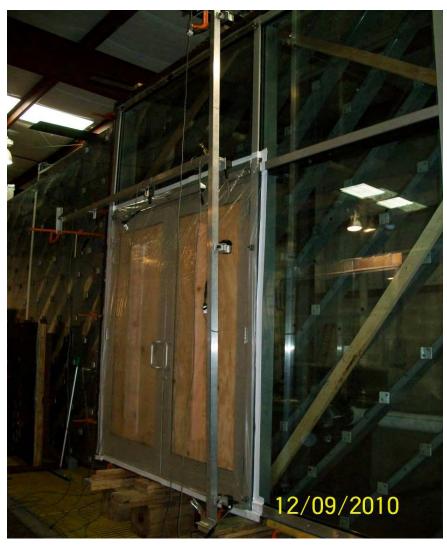
Photo No. 2 Indicator locations for Elevation E5

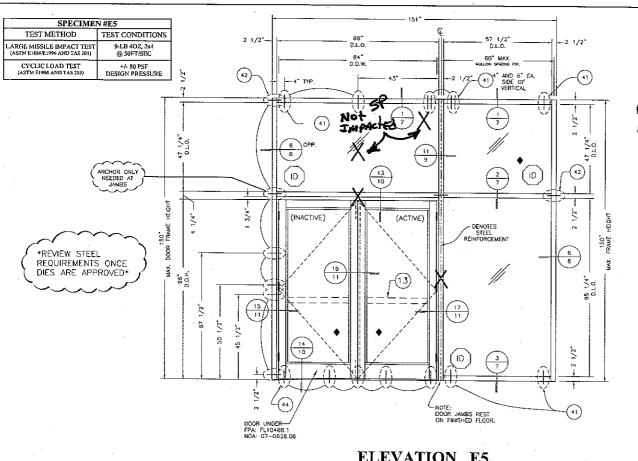
ELEVATION E5

CAPTURED MULLION -LONG SPAN-WITH SR150 & 3/4" x 3 5/4" BAR STEEL REINFORCEMENT FOR SERIES 381 ENTRANCE DOORS

STEEL BUCK FRAME TESTING: IMPACT, AND CYCLE

MAX. ALLOWABLE DEFLECTION (L/180)= 0.833

DESIGN PRESSURE = $\pm /-80$ PSF

= LARGE MISSILE IMPACT LOCATIONS
